Report Card:

2001 BMW 525i Motorsport Edition (Black)

1.0 Enrolment:

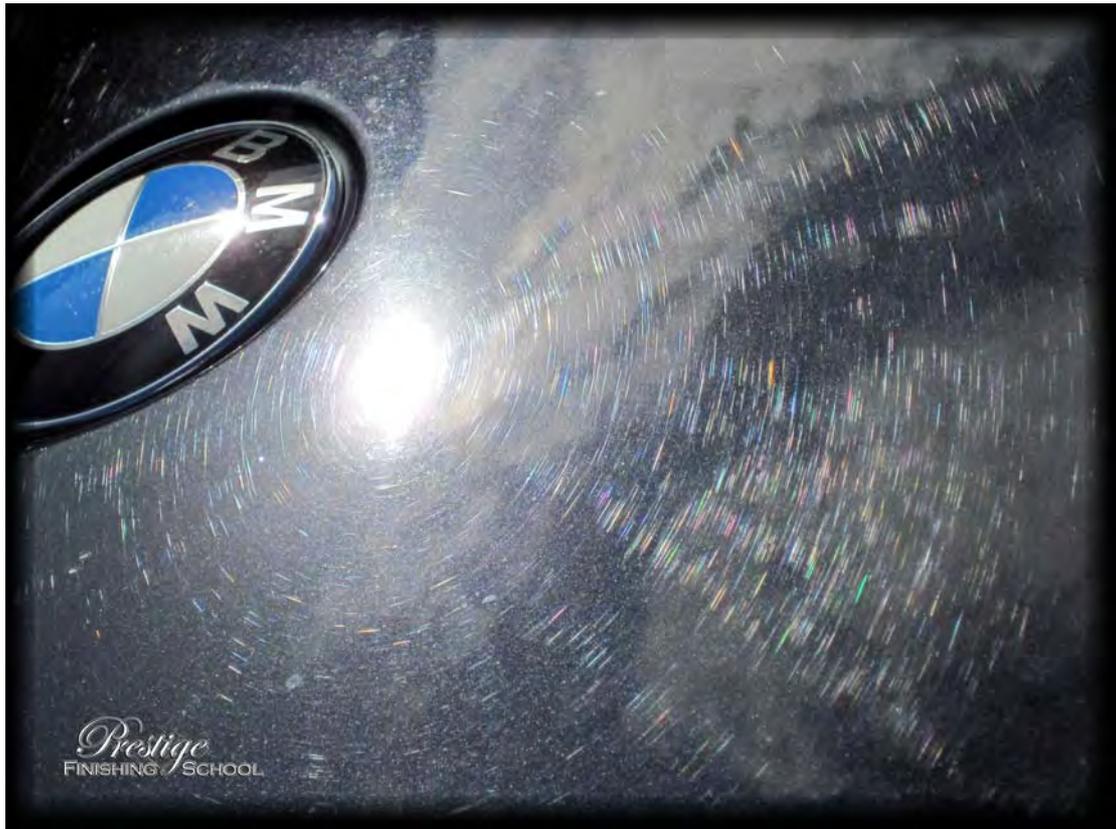
On delivery, the owner's concerns became immediately apparent, with harsh swirl marks clearly ruining the paint's reflectivity and clarity – especially on the bonnet.

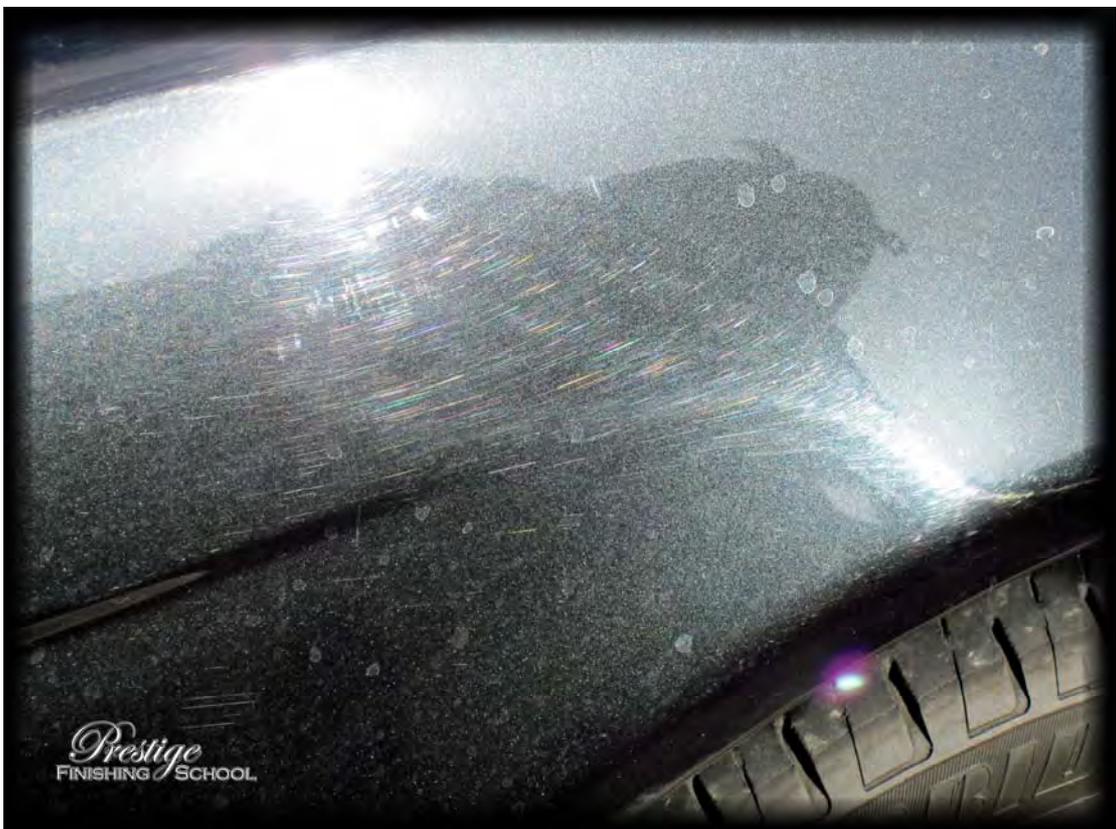
Other panels had also been subjected to abrasive cleaning.

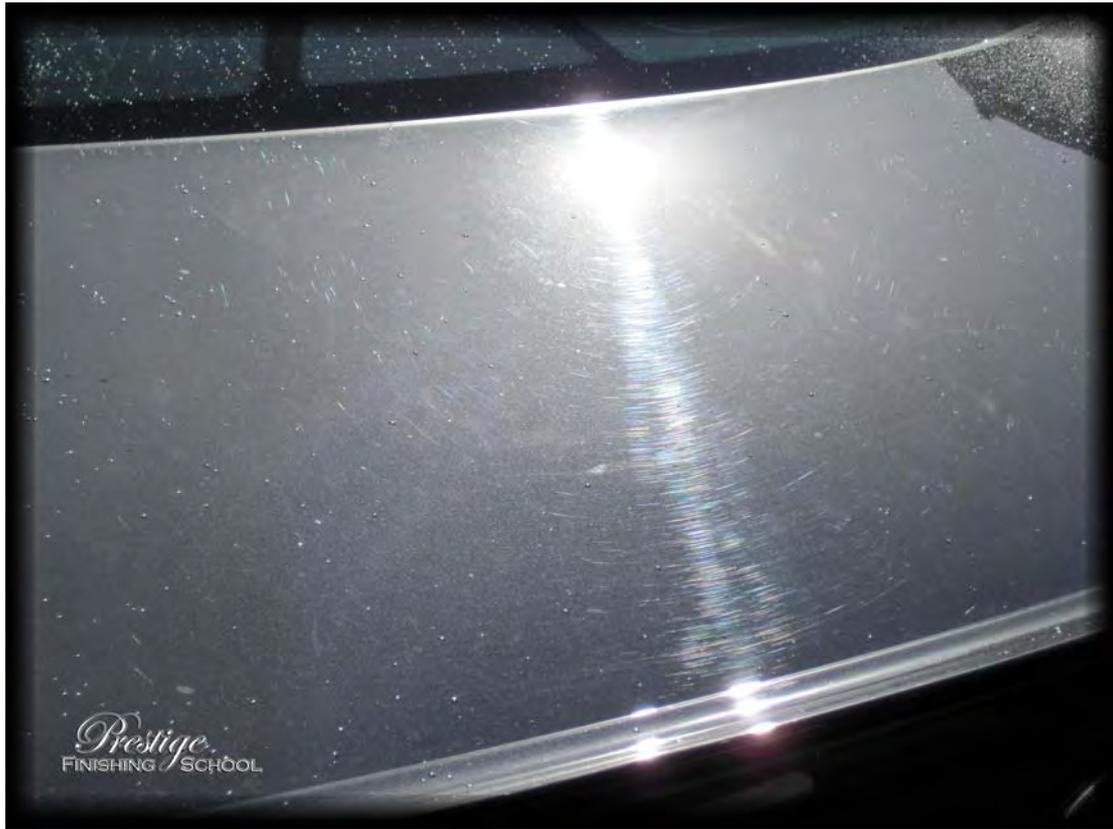
And the boot lid was another area that the owner was particularly disappointed with.

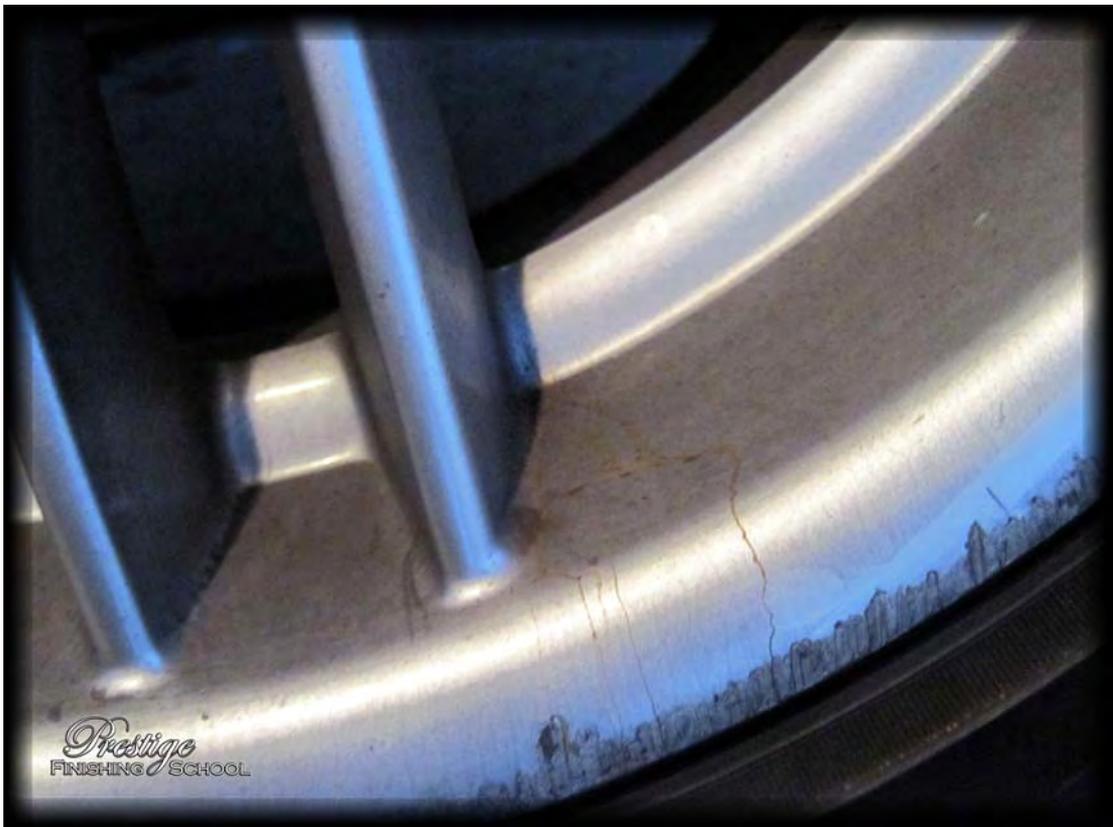
In addition, there was unfortunate 'kerb' damage to each of the vehicle's rims. While we do not provide 'wheel repair' services, we would endeavor to make these as presentable as possible.

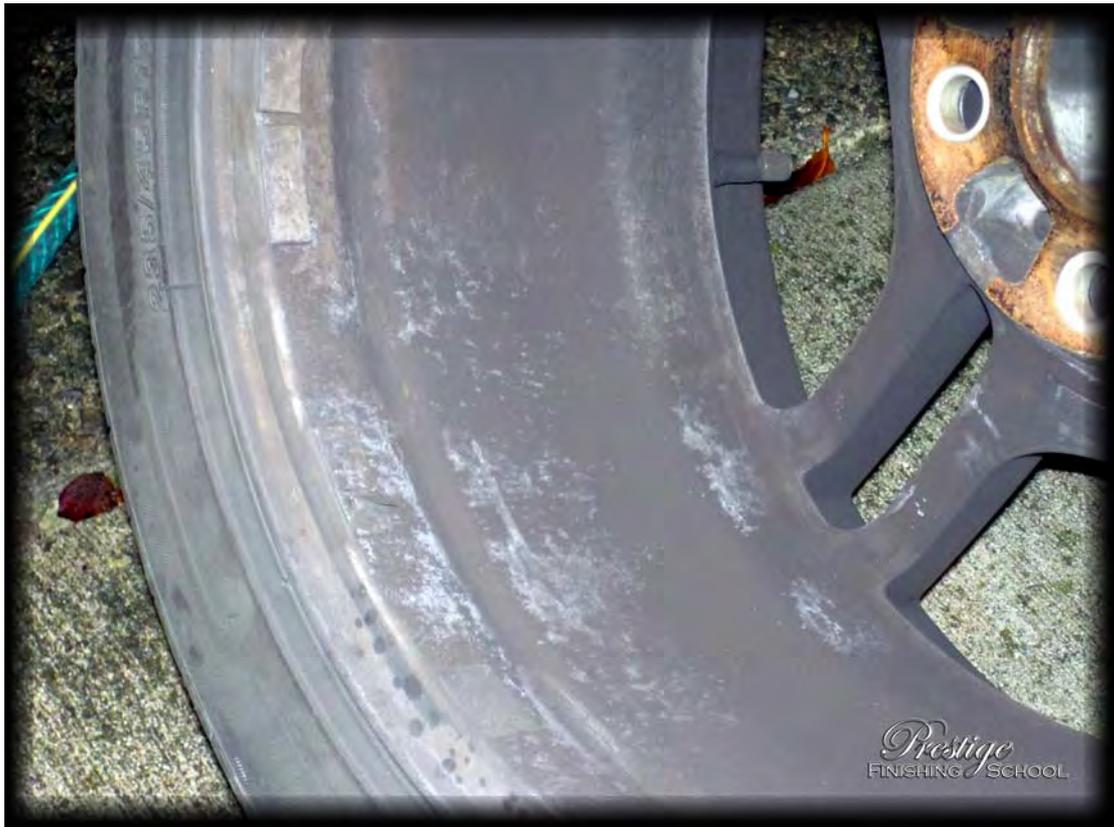
The front rims were showing significantly greater etching and staining, possibly due to a more aggressive brake pad being employed...

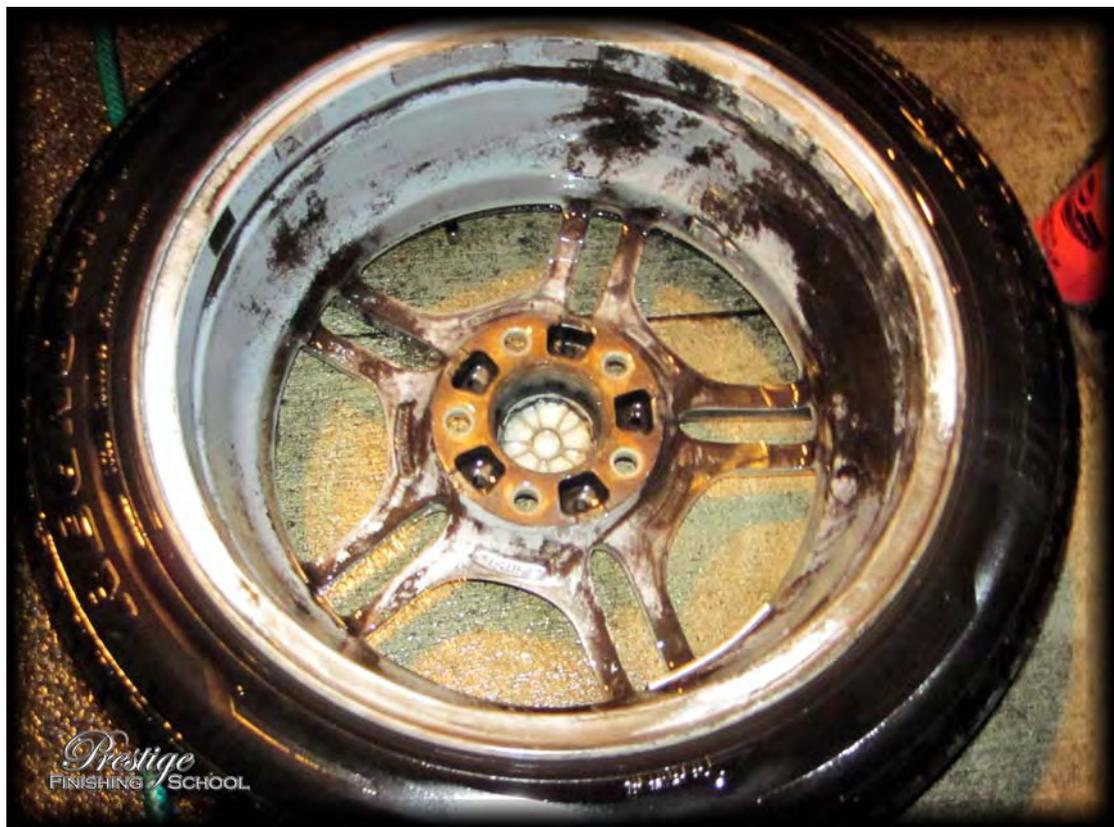
...a thorough scrubbing with the Menzerna Wheel Gel still left this behind:

Stepping up the 'aggressiveness' of the cleaning process, we turned to "Meguiar's Wheel Brightener", with the following results.

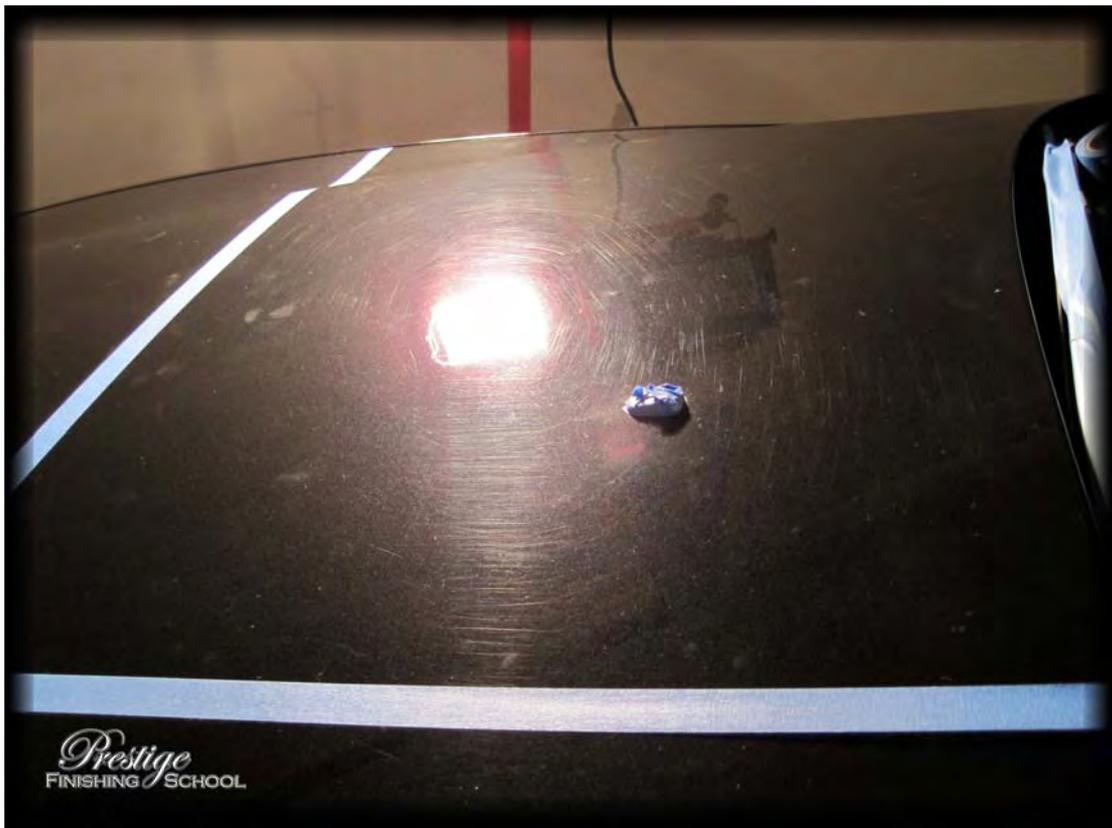
Bonnet

This was the condition of our 'test' area prior to starting. Paint thickness (as illustrated in the following diagram) was consistent across the panel, and averaged a fraction under 100 μm in total thickness.

BMW paint has a reputation for being "rock hard" and this specimen turned out to be no exception! We quickly graduated from finishing polishes to Menzerna 106FA on a 3M polishing pad which has a bit more 'cut', but this wasn't touching the defects. Eventually we settled on Menzerna "Power Finish" PO85 RD 3.02 on a 3M compounding pad.

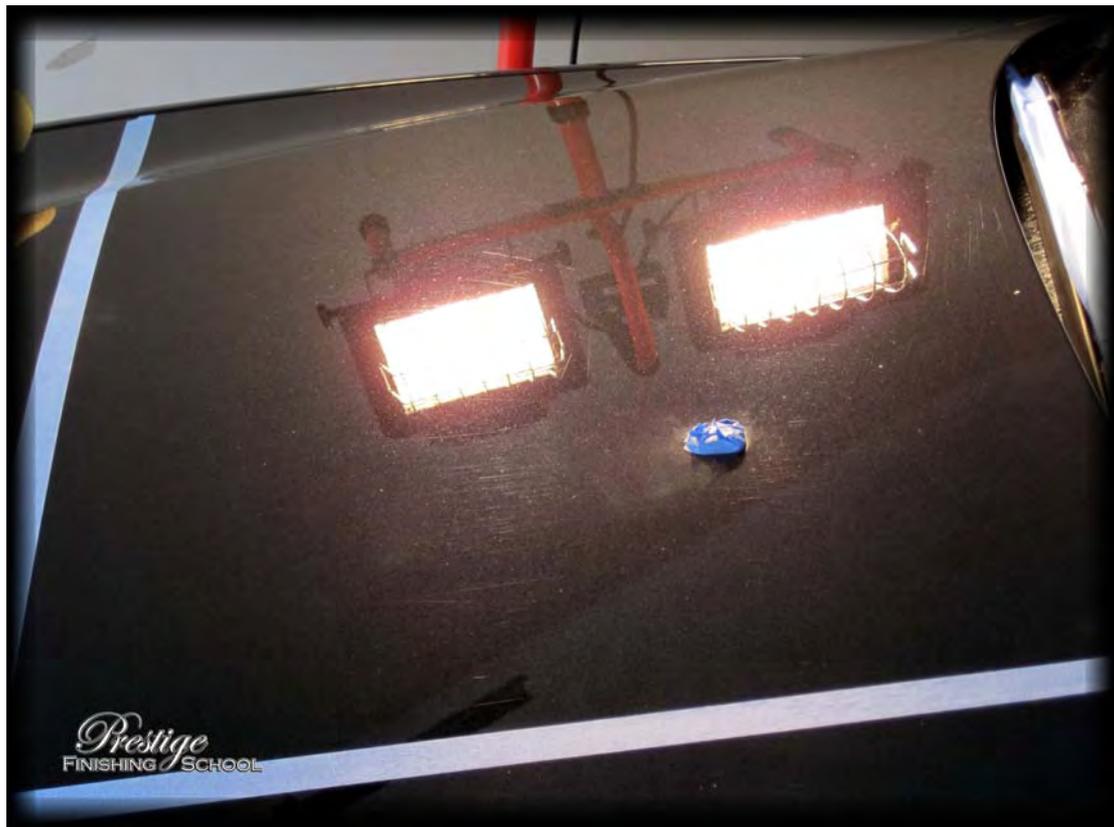
This is the level of correction after a single pass of the RD3.02. Much improved, but some deeper scratches are still evident in the paint.

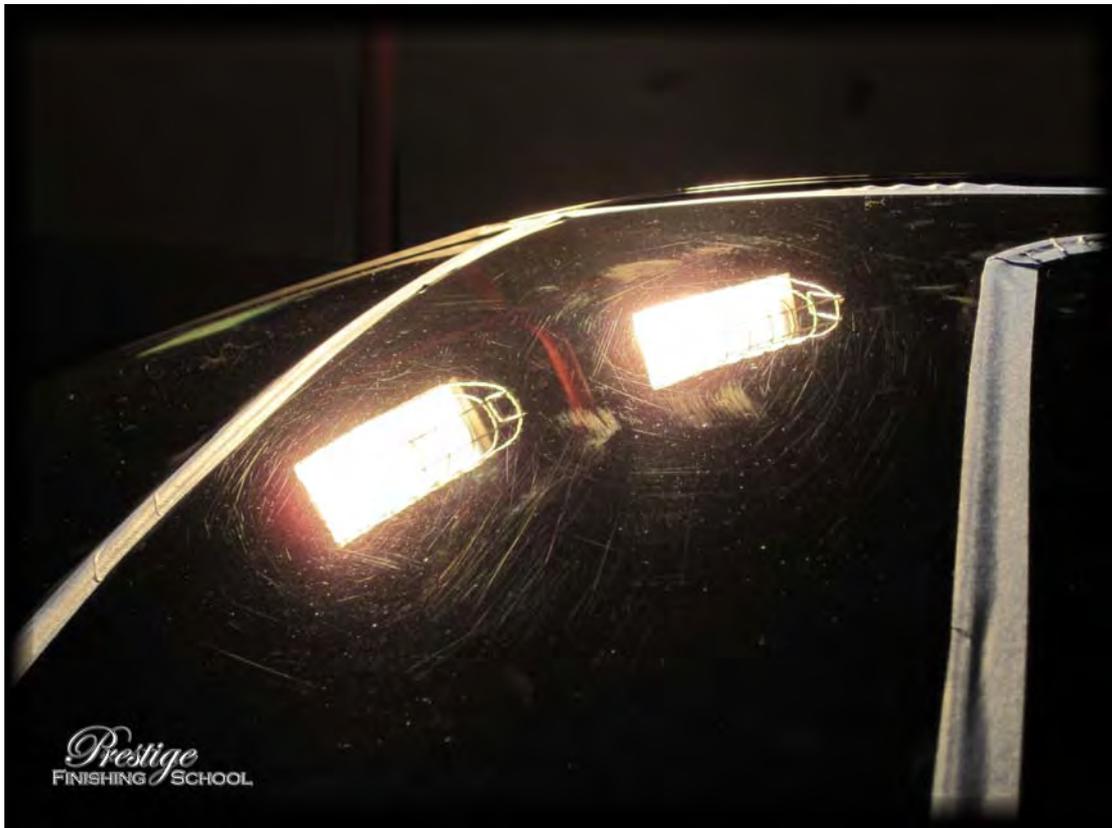
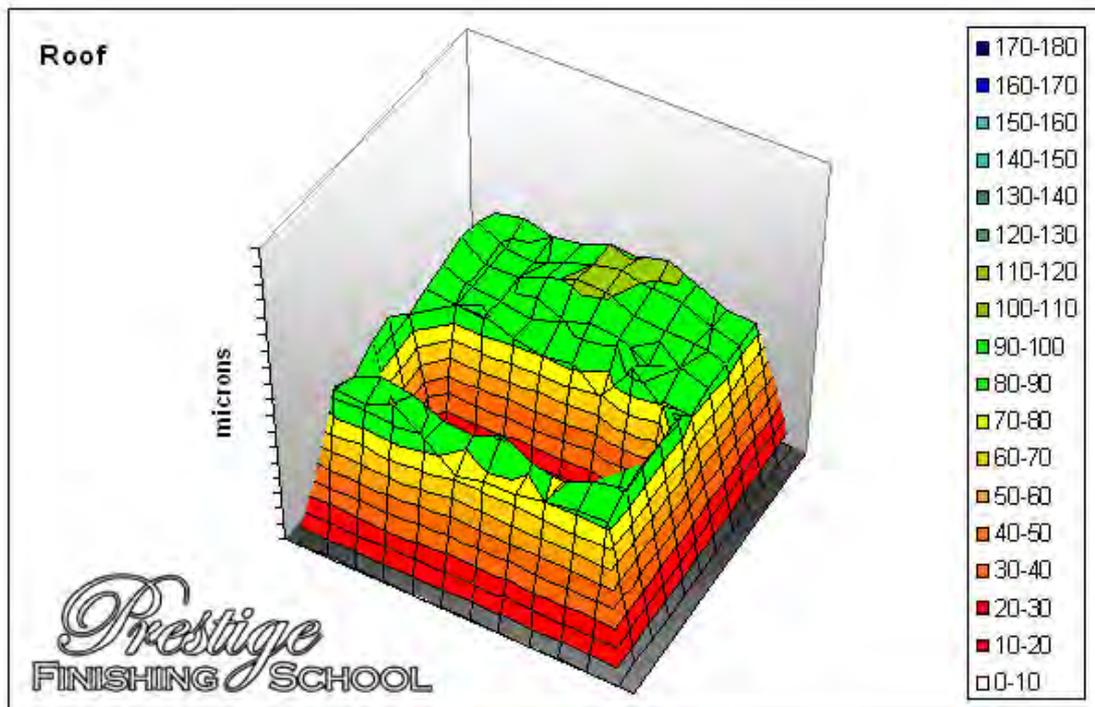
Roof

The roof was also showing significant marring with some reasonably deep scratches as well.

(The gap in the middle of the thickness graph is due to the glass sunroof)

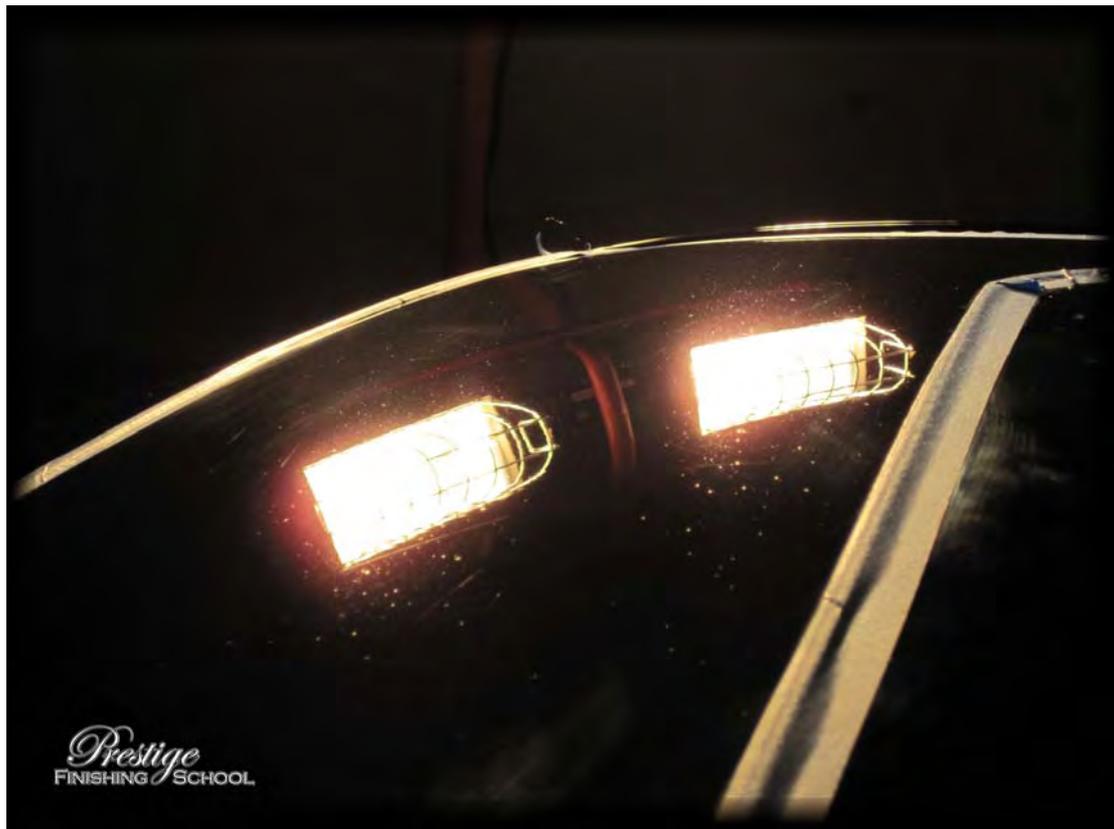
This picture illustrates the 'haze' left by aggressive compounds. This is an example of the 'micro-marring' that requires a follow-up with a refining or finishing polish.

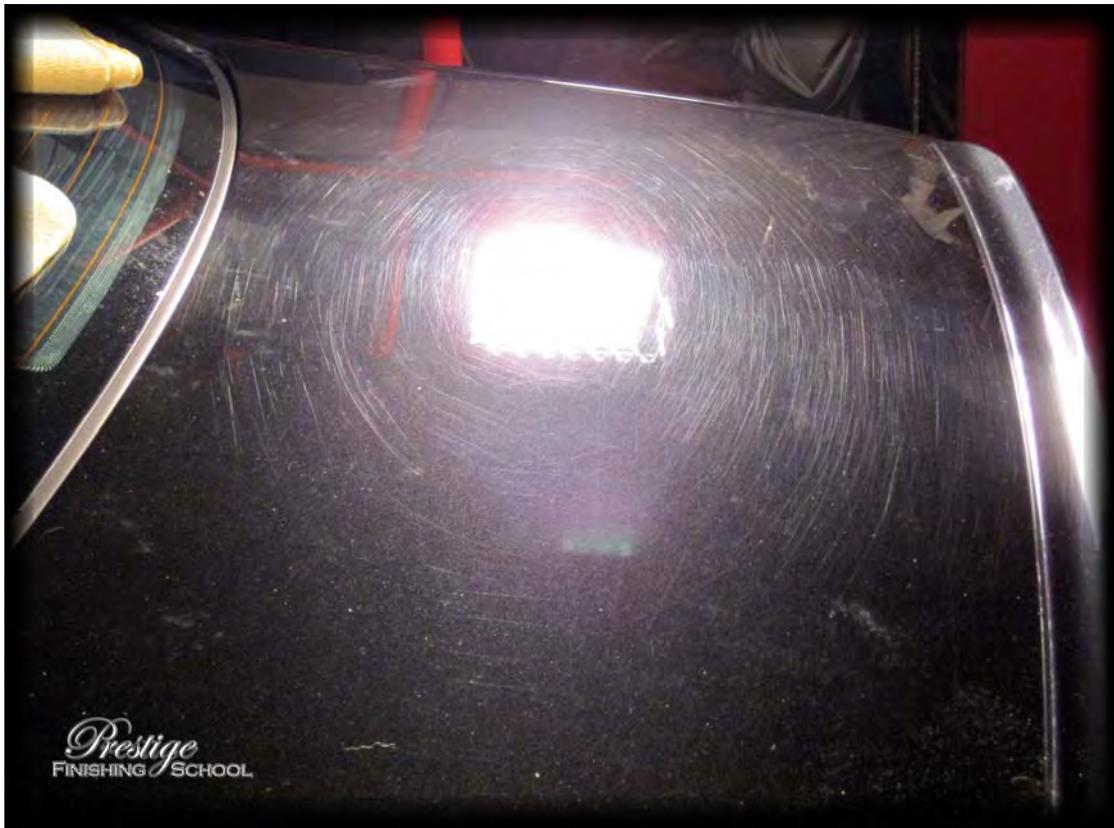
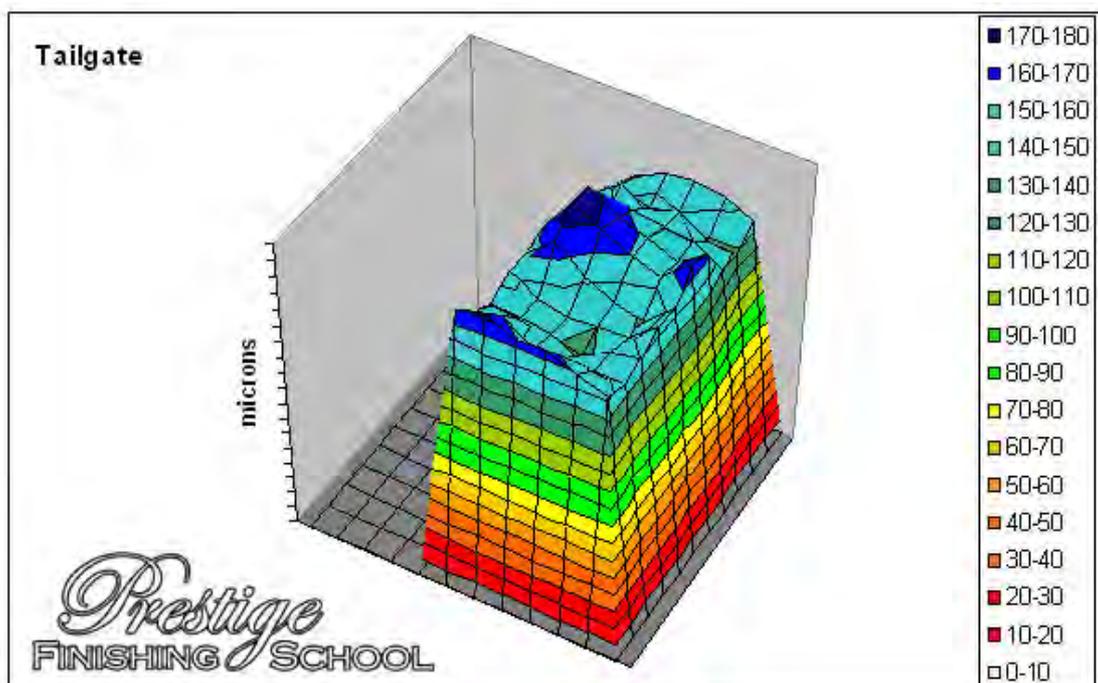
Boot

This panel was another area of particular concern for the owner. Understandably so!

Paint thickness here was a little on the 'high' side, possibly indicating a re-sprayed panel. As such, we started from scratch, working our way up the scale of polishes, just in case this paint was significantly 'softer' than the extremely hard factory finish.

It eventuated that this was factory paint after all, but it is always better to err on the side of caution. (At least, in our opinion.)

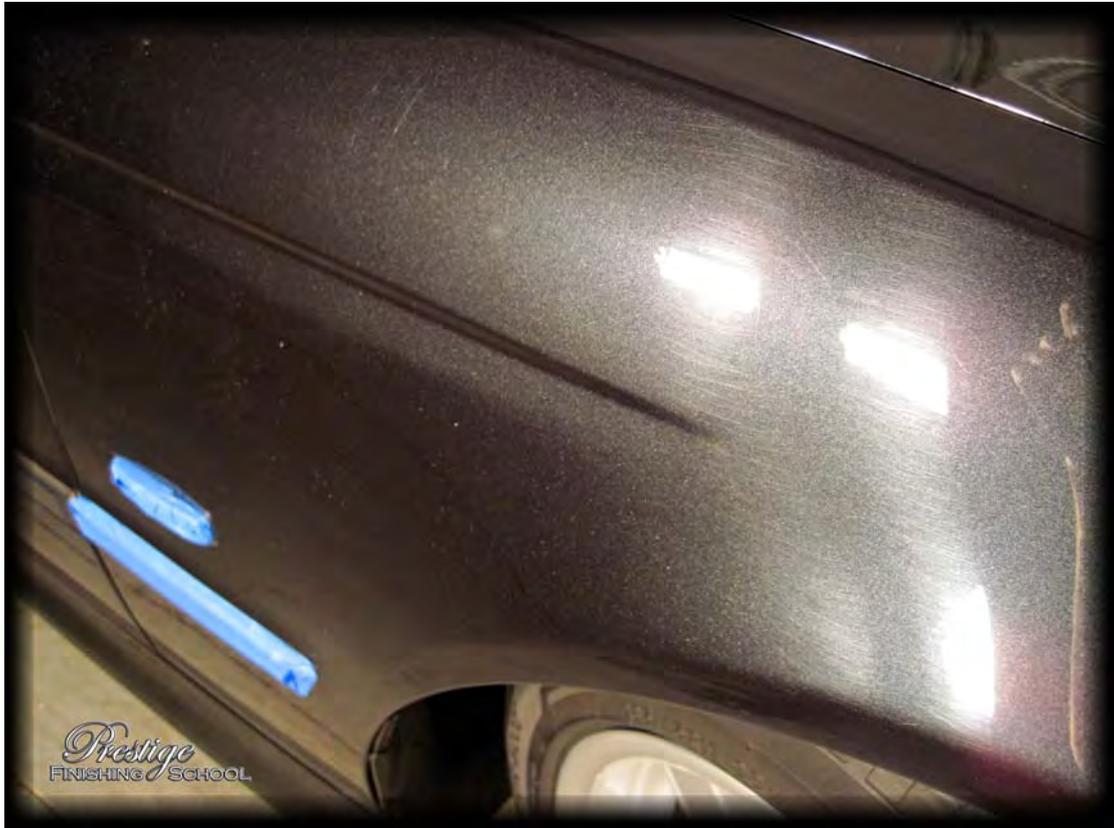
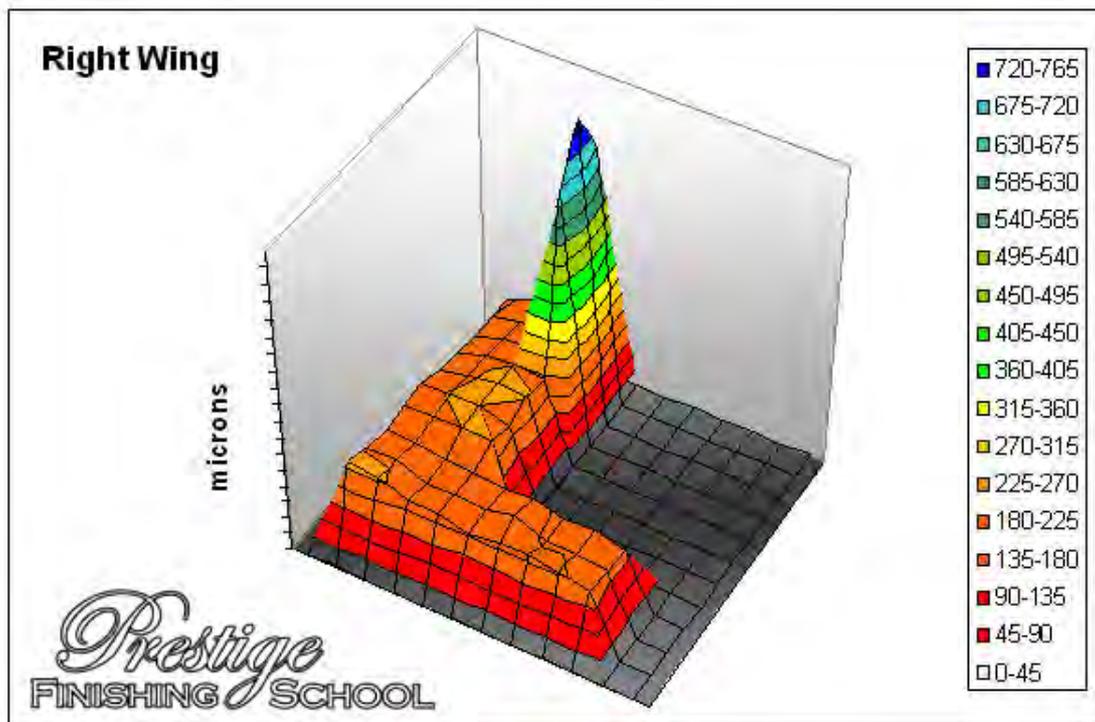
Right Front Wing

This panel had certainly been re-sprayed. Note carefully the 'scale' of the surface measurements in the diagram below and you'll see that it is roughly double that of the other panels so far. Of greater concern is the marked variance in the paint thickness across the panel.

We proceeded with caution... The panel finished perfectly.

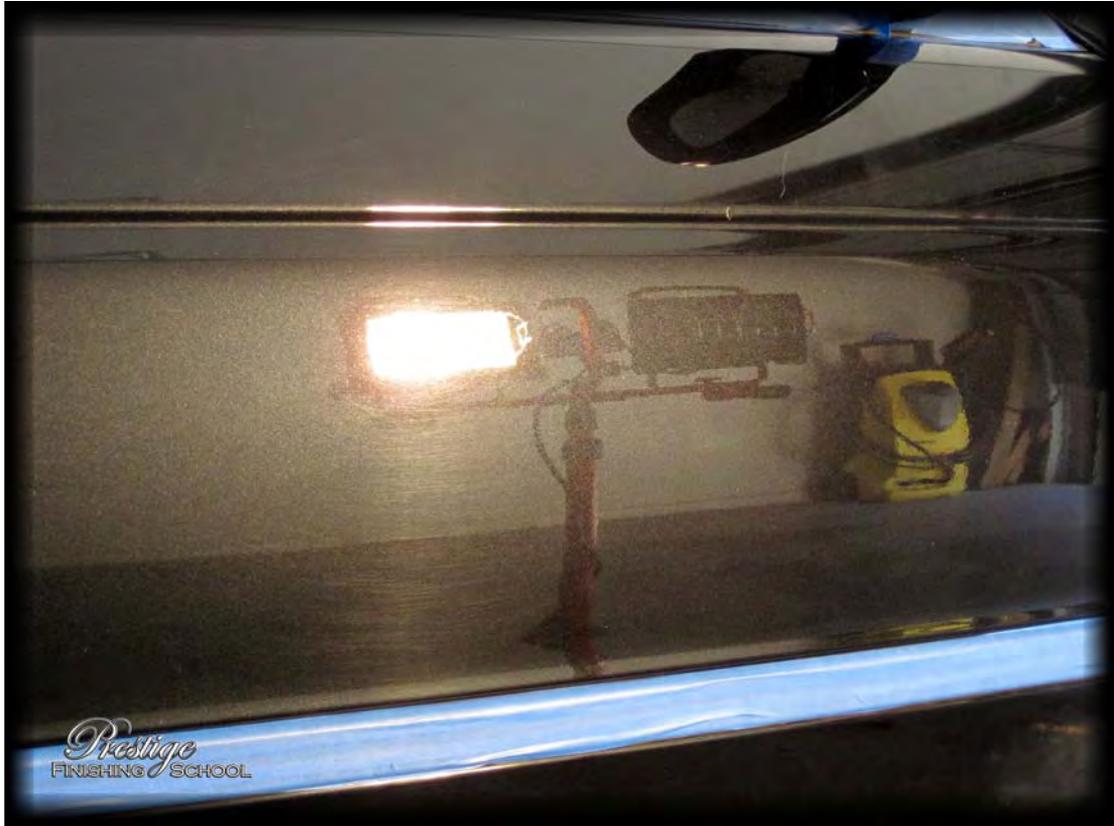
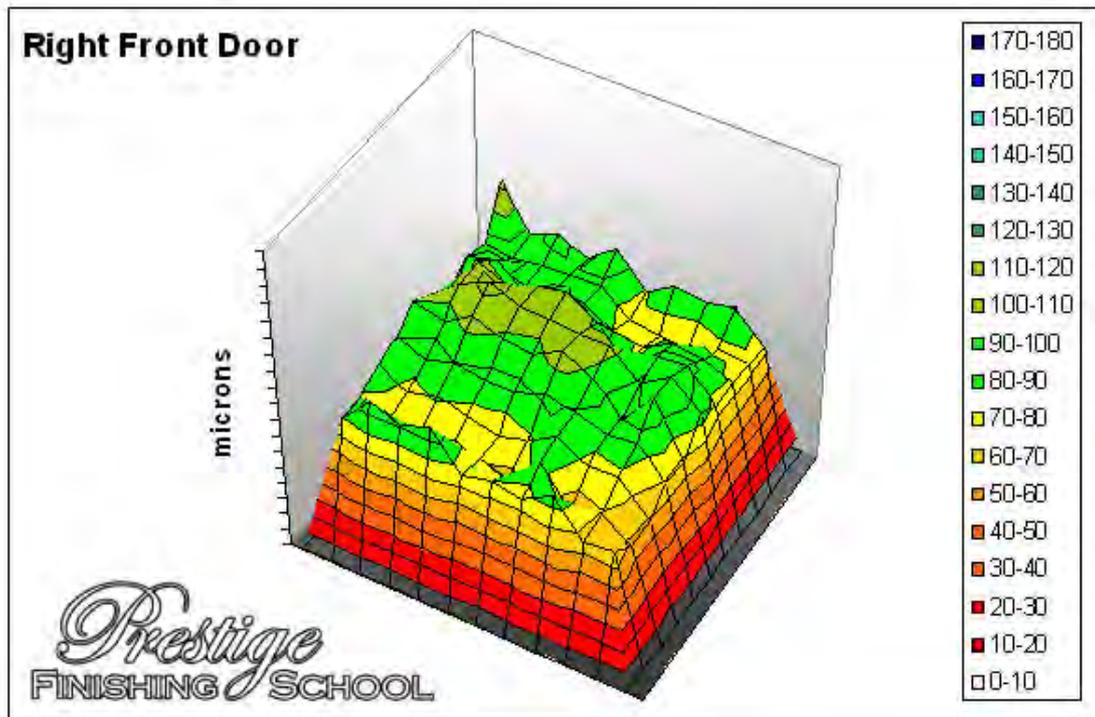
Right Front Door

The only small area of concern with the driver's door was a 'touched-up' spot on the panel's crease. Otherwise, minor swirl marks were the order of the day.

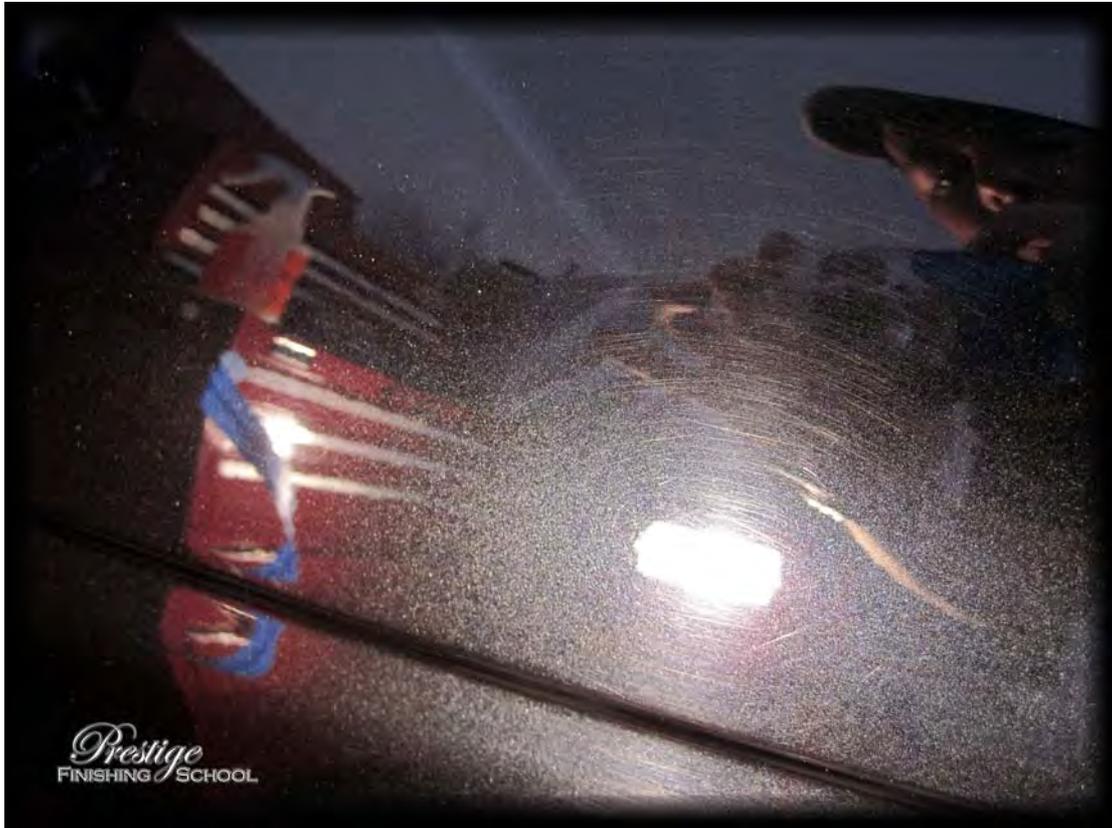
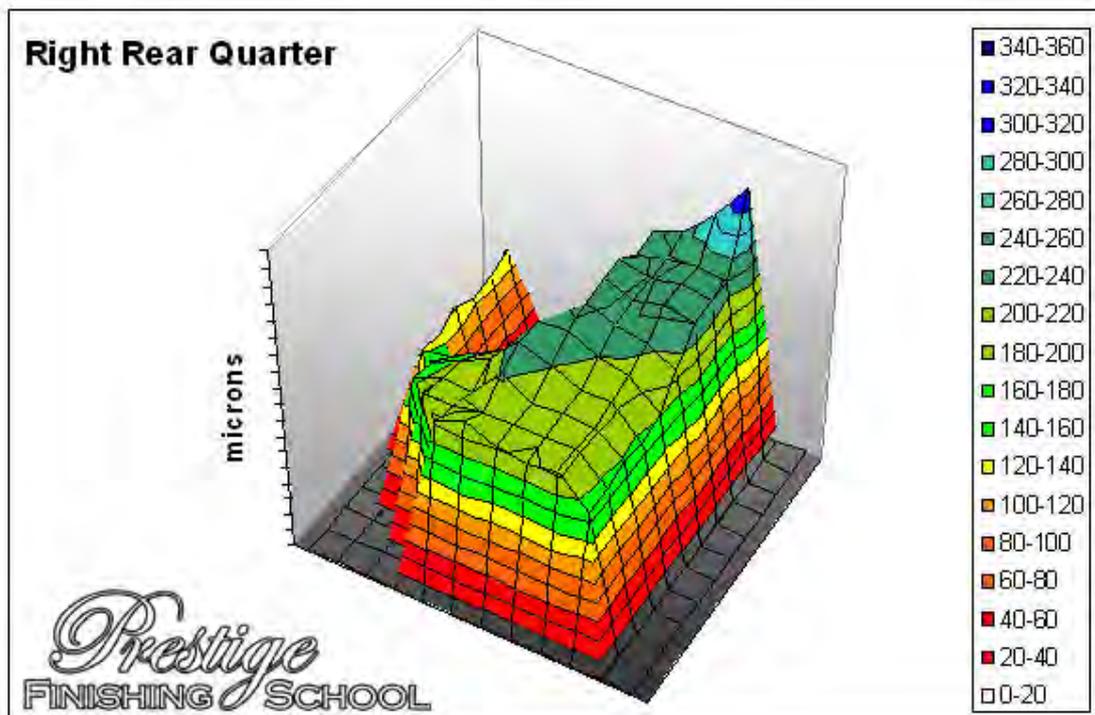
Right Rear Quarter

This section had also received some attention in a spray booth. The paint finish was again roughly double, but it seemed to be a quality job, with the new paint blended nicely on the "C Pillar". Close up shots here show how the 'sparkle' of the pearl in the paint is diminished by paint defects.

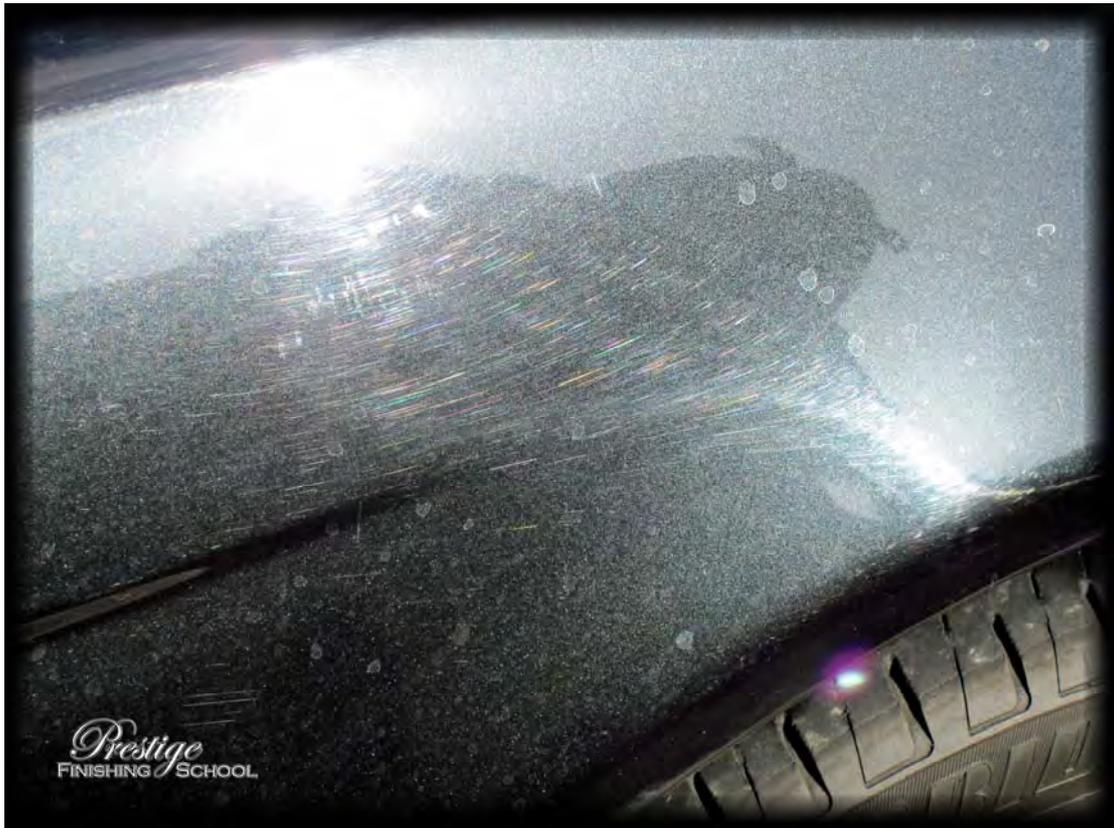
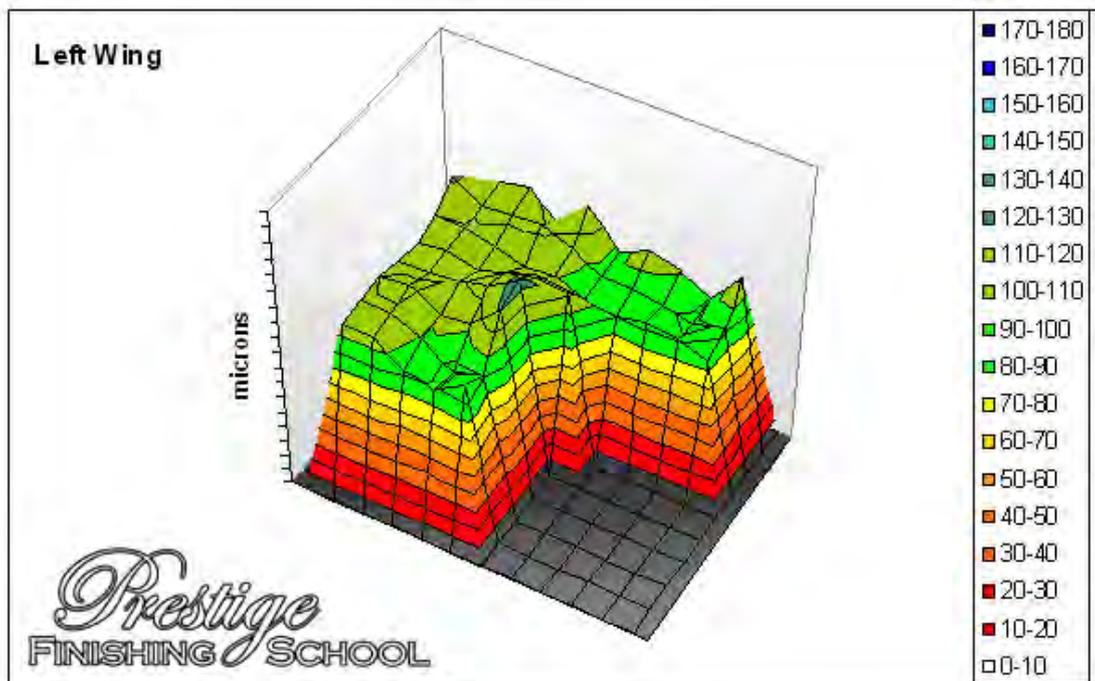
Left Front Wing

The passenger's side of the vehicle was consistent, hard, uniform factory paint.
