**Report Card:**

2001 Holden VX Commodore (Red)

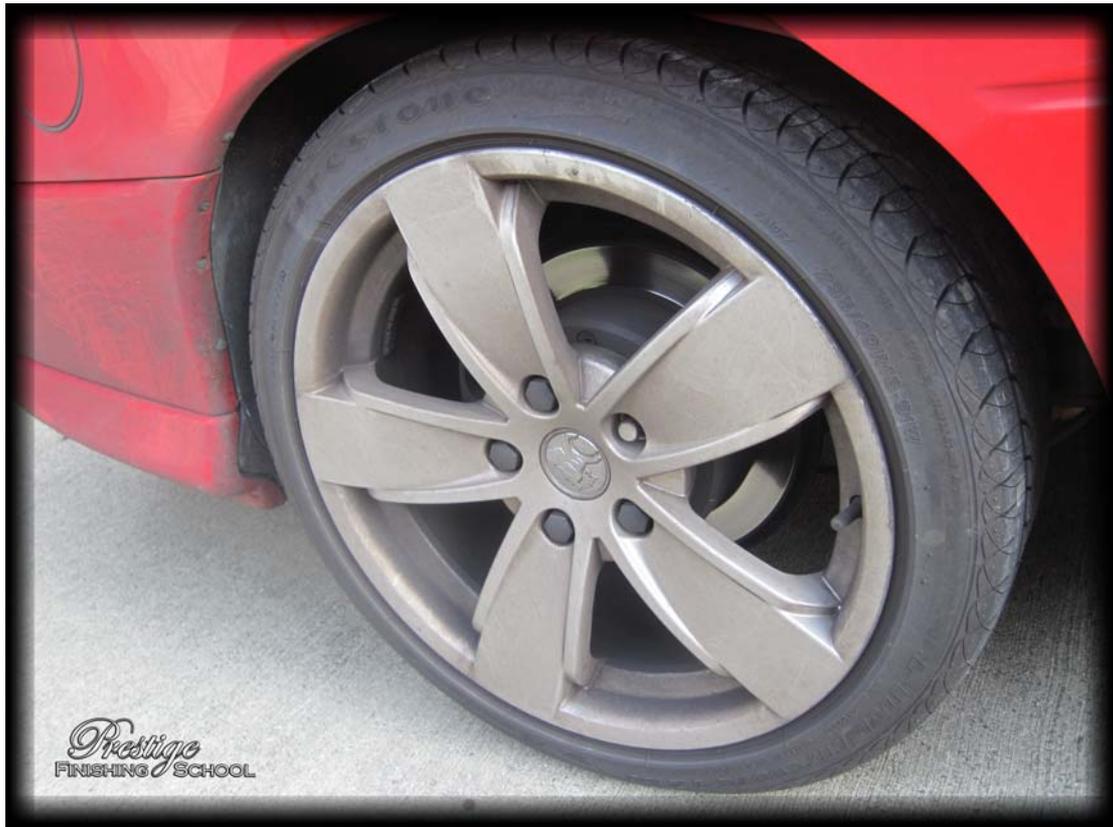
The wheels themselves were looking decidedly “brake dust brown” instead of the bright silver that they ought to.

The wheels themselves were cleaned with various brushes, and a weak solution of Meguiars Wheel Brightener.

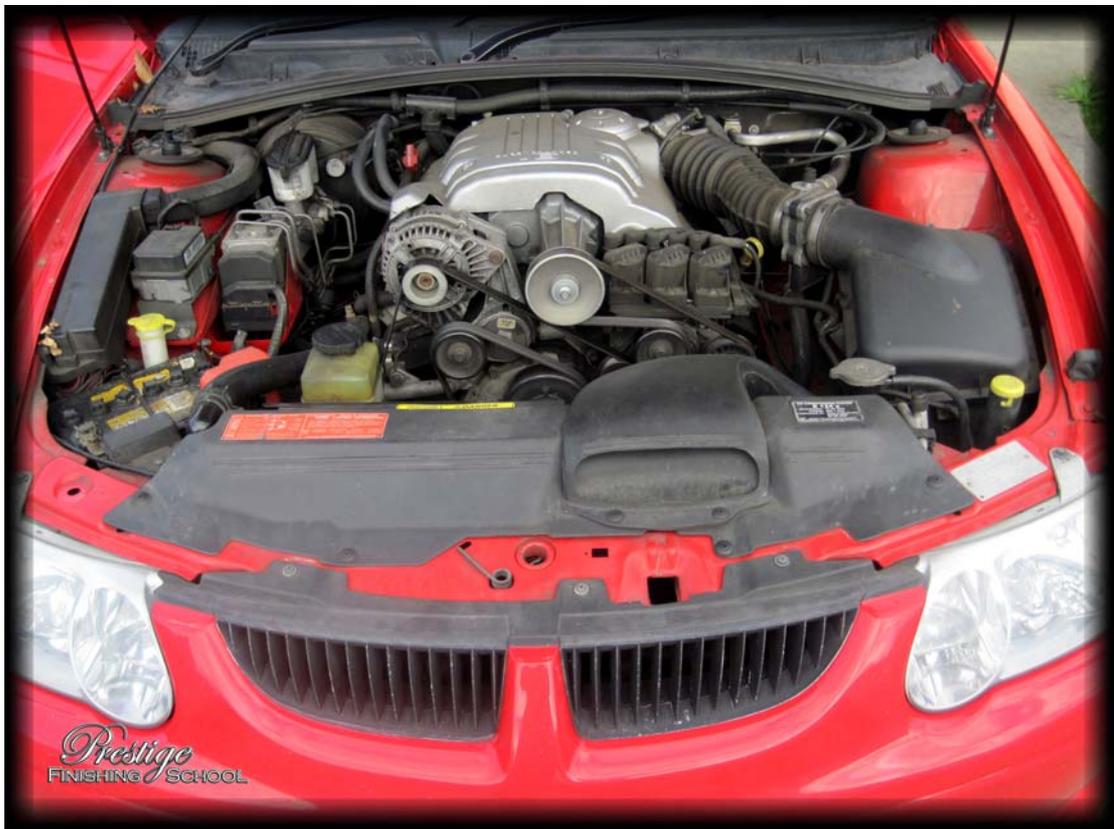
We commence with the Engine Bay. Plenty of grime and dust present, as well as some nasty staining/fading of the plastics.

The entire compartment was given a liberal spraying with Meguiars Super DeGreaser (diluted at 4:1 this time for a little extra bite) and agitated with a detailing brush. This was then rinsed off at low pressure, leaving the following results:

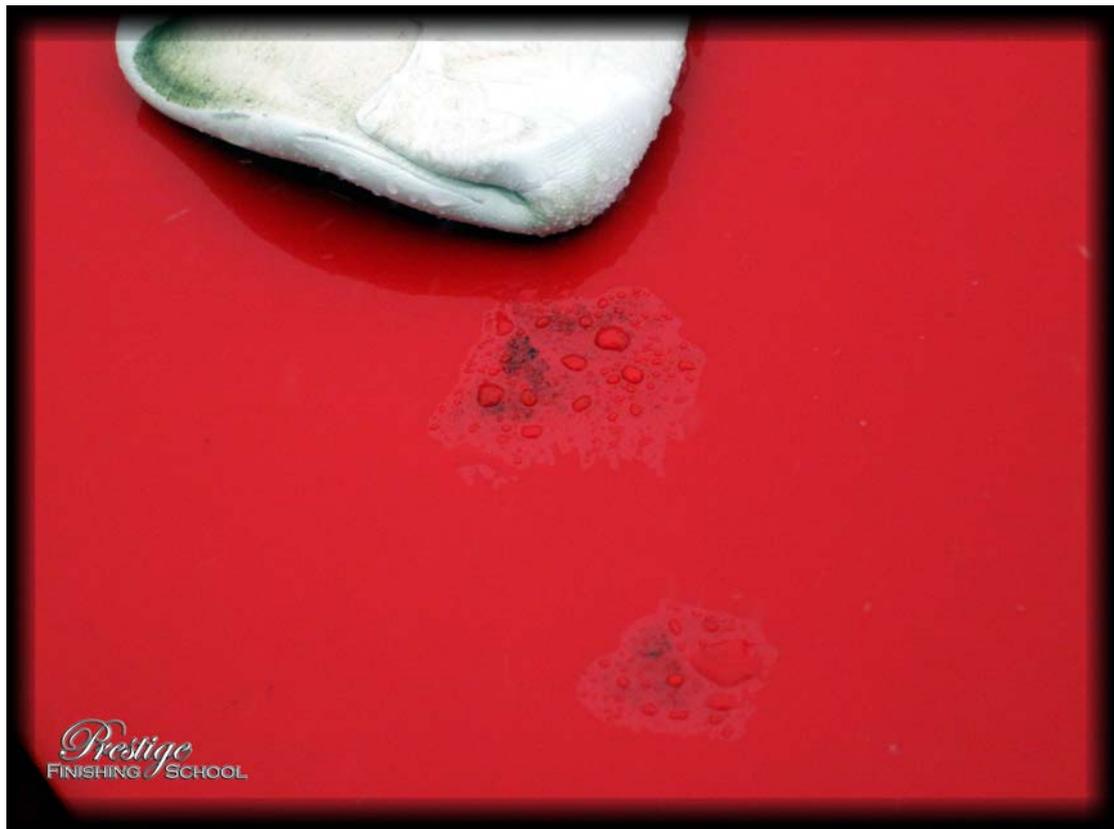
The boot lid was suffering the effects of bird droppings. These marks illustrate just how damaging it can be to leave these deposits unattended to.

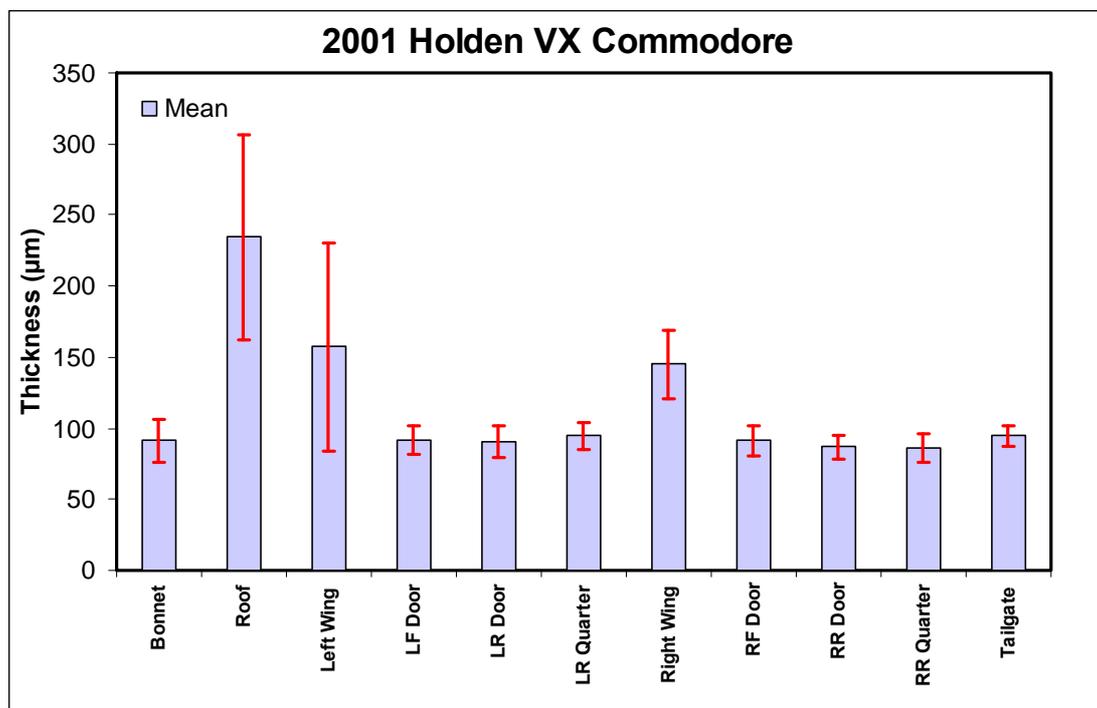
In total, nearly a thousand individual readings were taken, and all panels showed slightly lower than ideal readings, with obvious respray work on the roof and front wings.

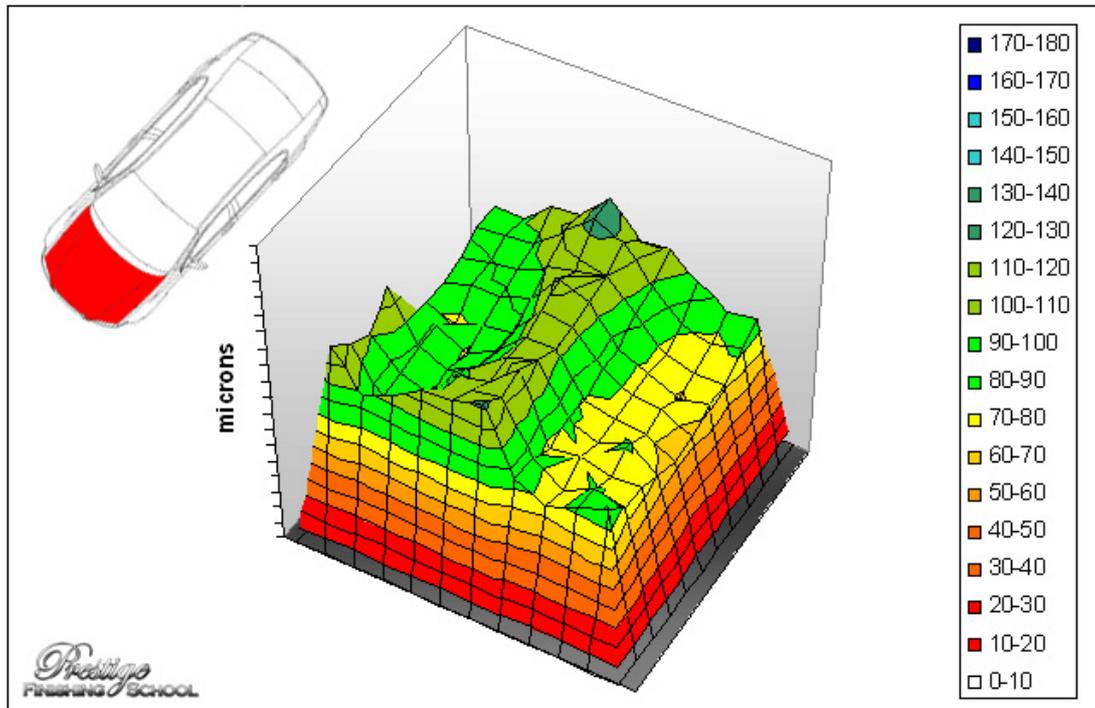
One interesting piece of information that the owner passed on was that after one visit to the paint shop, a panelbeater remarked that he had spent nearly 5 hours polishing to make the repair look right. Look carefully at the thickness diagram below and see for yourself what this caused. (Where the bonnet would meet the Left Front Wing)

Here the paint has become dangerously thin. (65-70  $\mu\text{m}$ ) Comparative measurements on areas of the vehicle that don't have a clear top coat (Eg. Inside the door shuts) indicated that the combined thickness of primer and colour coats was between 35  $\mu\text{m}$  and 45  $\mu\text{m}$  meaning that as little as 20  $\mu\text{m}$  of clear remained!

By using a Glaze rather than anything more aggressive, and limiting the machining to a maximum of 1200rpm we were able to achieve the following result with only a single micron removed from the top coat.

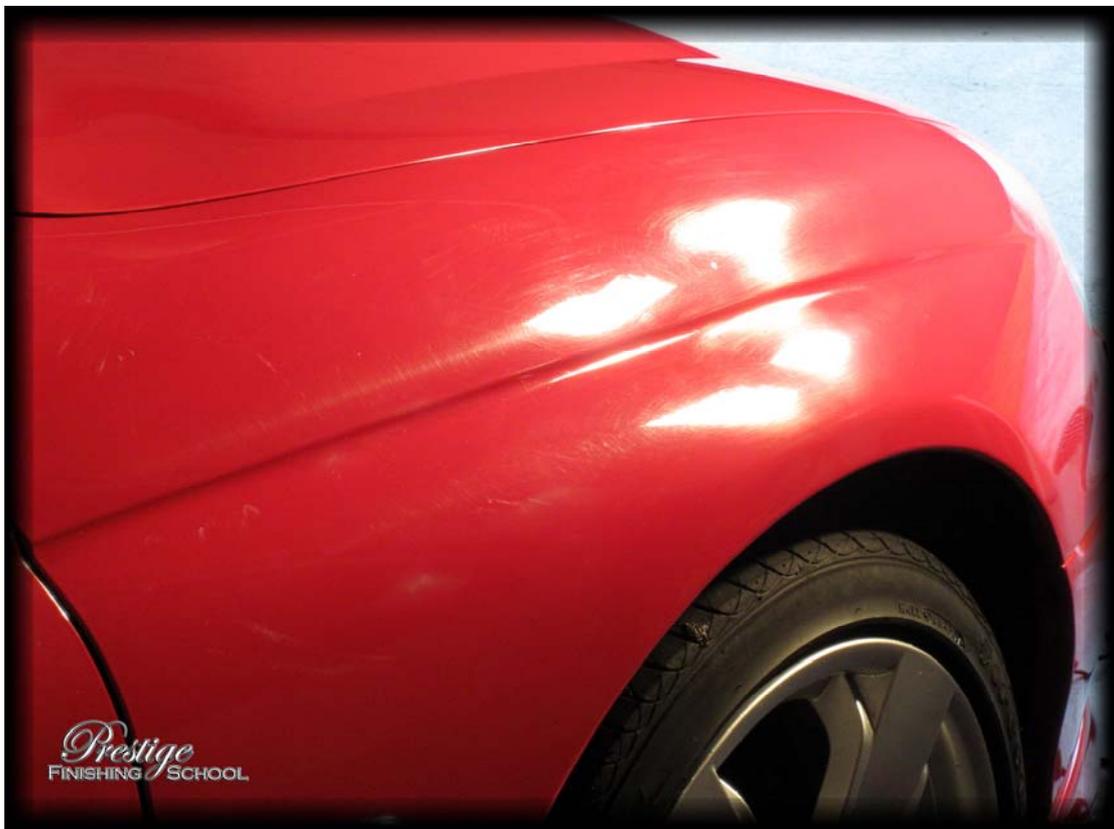
The usual assortment of swirl marks and fine scratches can be seen around the light sources.

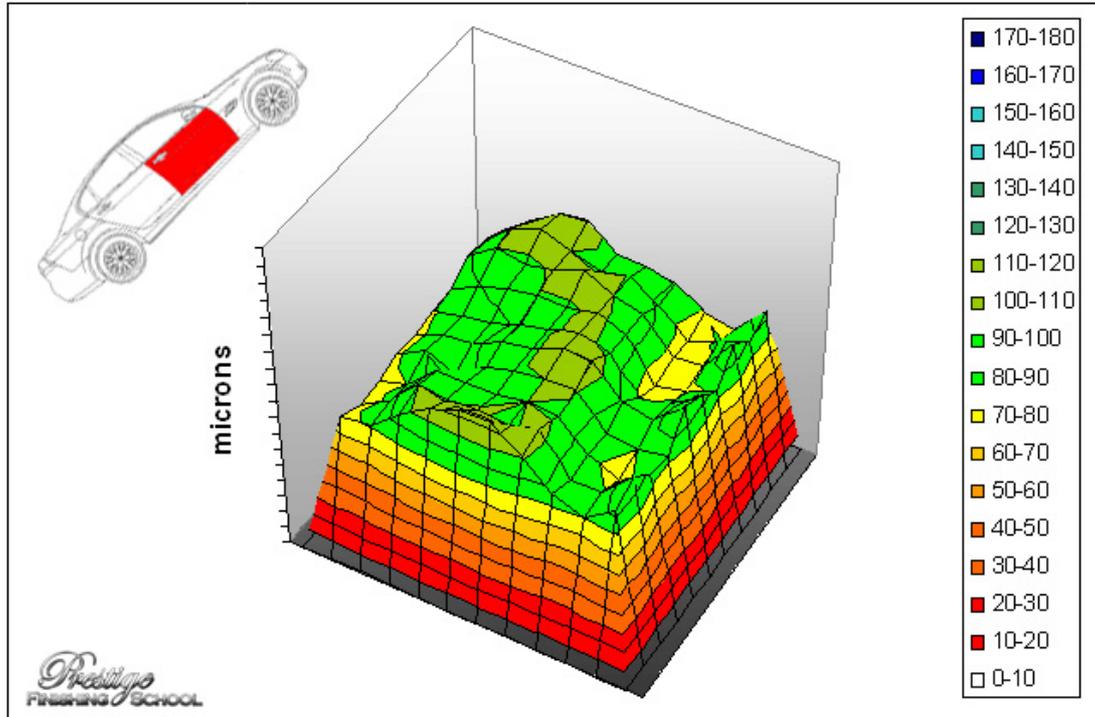
The doors down the right of the vehicle wore original paint that was dipping down into the 70-80  $\mu\text{m}$  range in some spots. As we had not yet found any 'strike through' of the clear coat despite the red paint transfer, we were still playing it very safe...

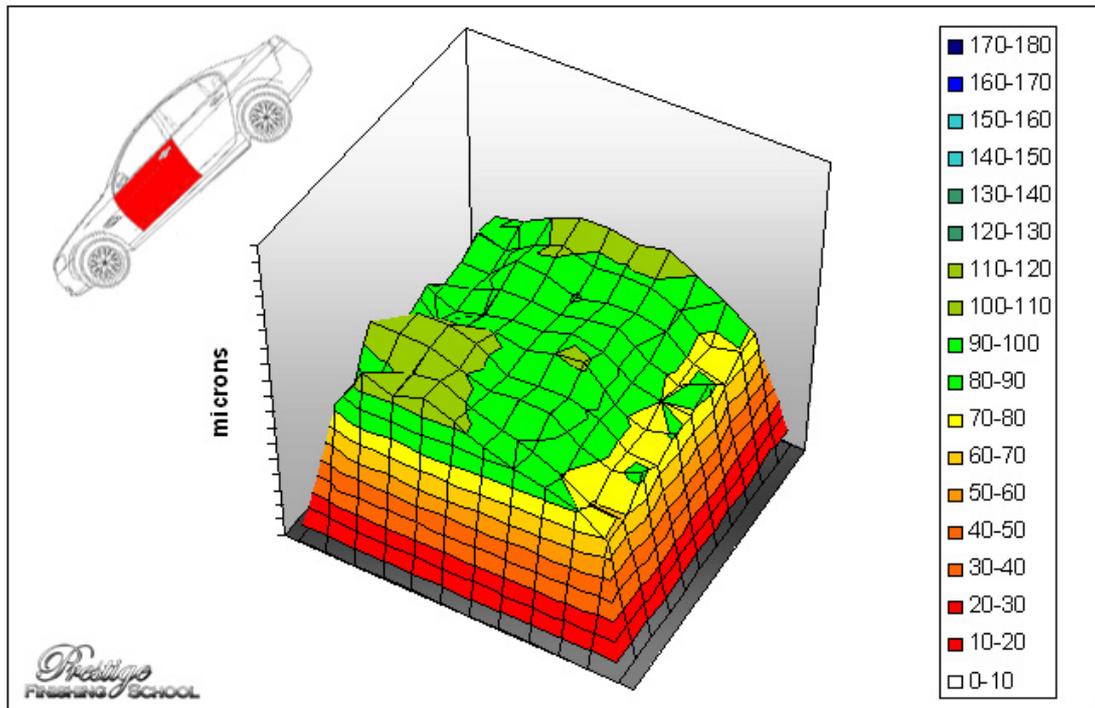
The paint levels on the left side doors was original, and again getting uncomfortably thin in places (especially on the rear door)

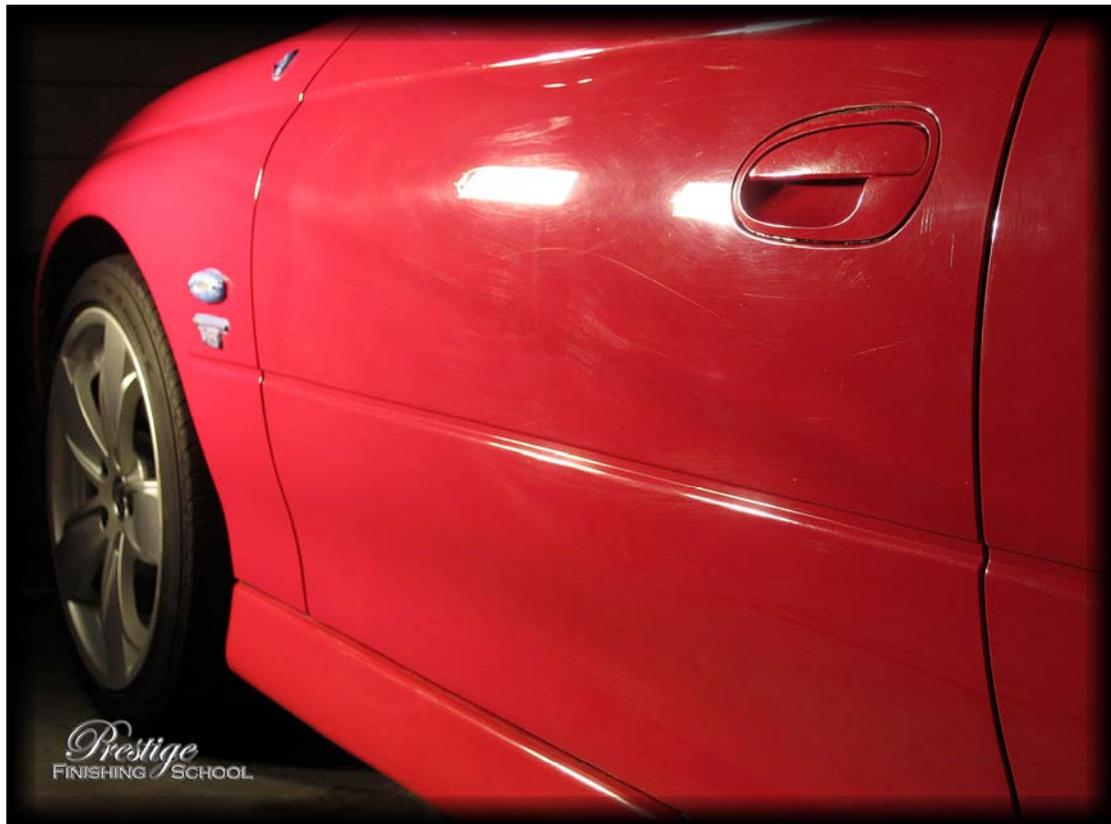
There was a mixture of fine scratches as well as deep paint defects detracting from this panel's appearance.

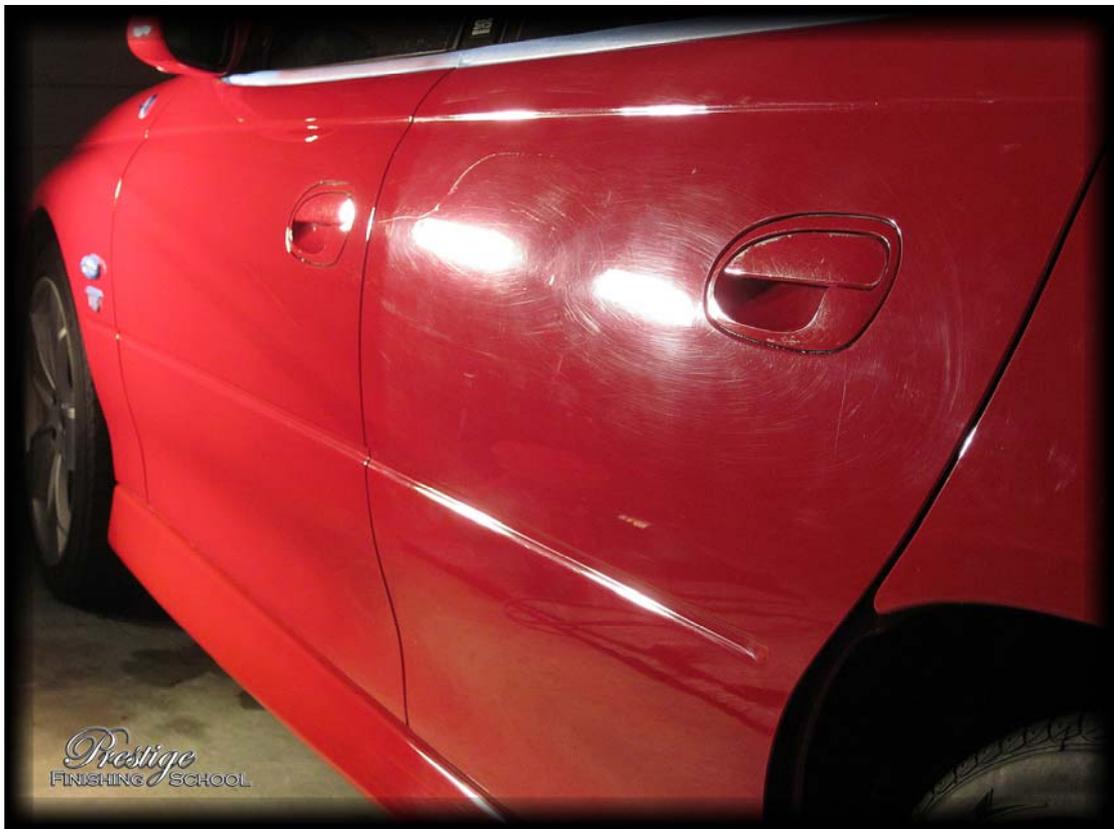
As well as having some of the thinnest paint, this panel had suffered the worst damage in terms of deep scratches.

In these situations, it becomes a judgment call on how far to take corrective work before the paint integrity becomes compromised.

Here, a vastly improved panel is the end result, and is achieved without removing large amounts of paint. Removing the last few remaining defects would not be possible without undue risk.

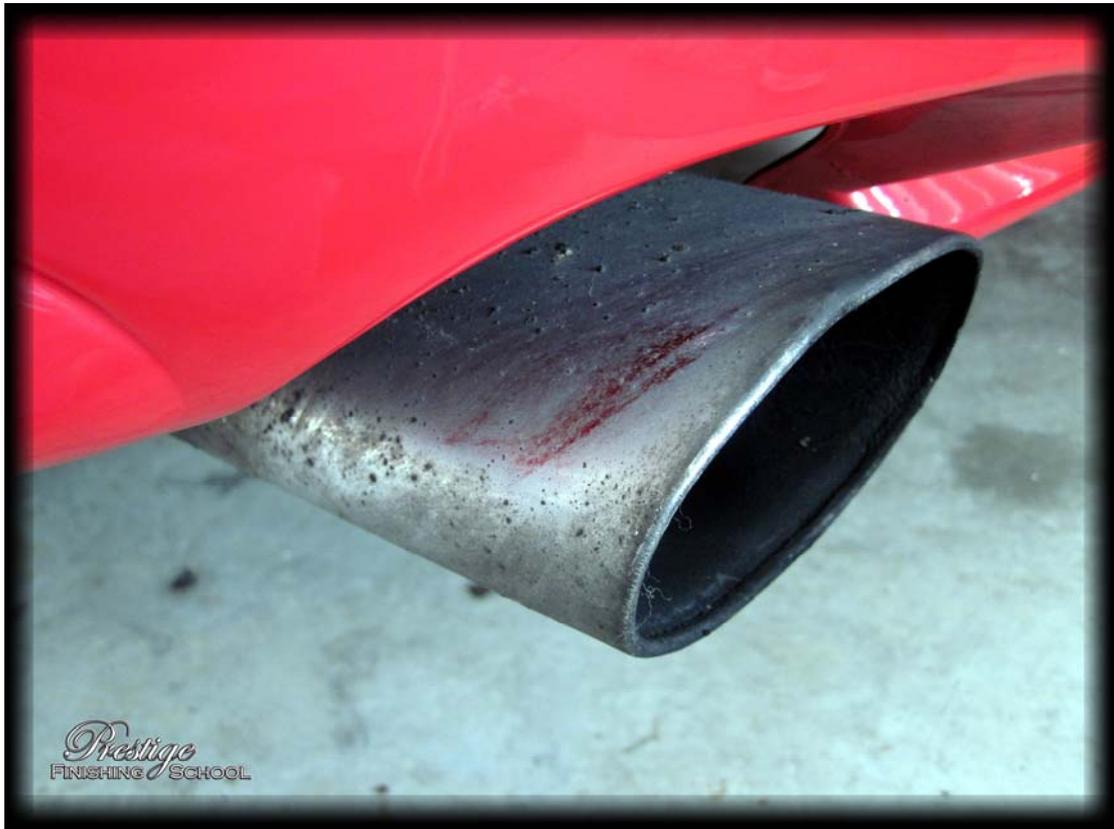
While the sealant was curing on the paint, the exhaust tip was taken care of. For those readers still wondering about the red ‘paint’ transfer into our wash buckets and claybar (as well as a fair amount onto our polishing pads as we set about correcting the paint) the mystery is finally answered here.

Tell-tale product residue... This vehicle had been covered in Turtle Wax “Color Magic” Red Wax. A rather unnerving situation for a detailer when combined with extremely thin paint turns out to be completely innocuous!
