Report Card:

2001 BMW 525i Motorsport Edition (Black)

1.0 Enrolment:

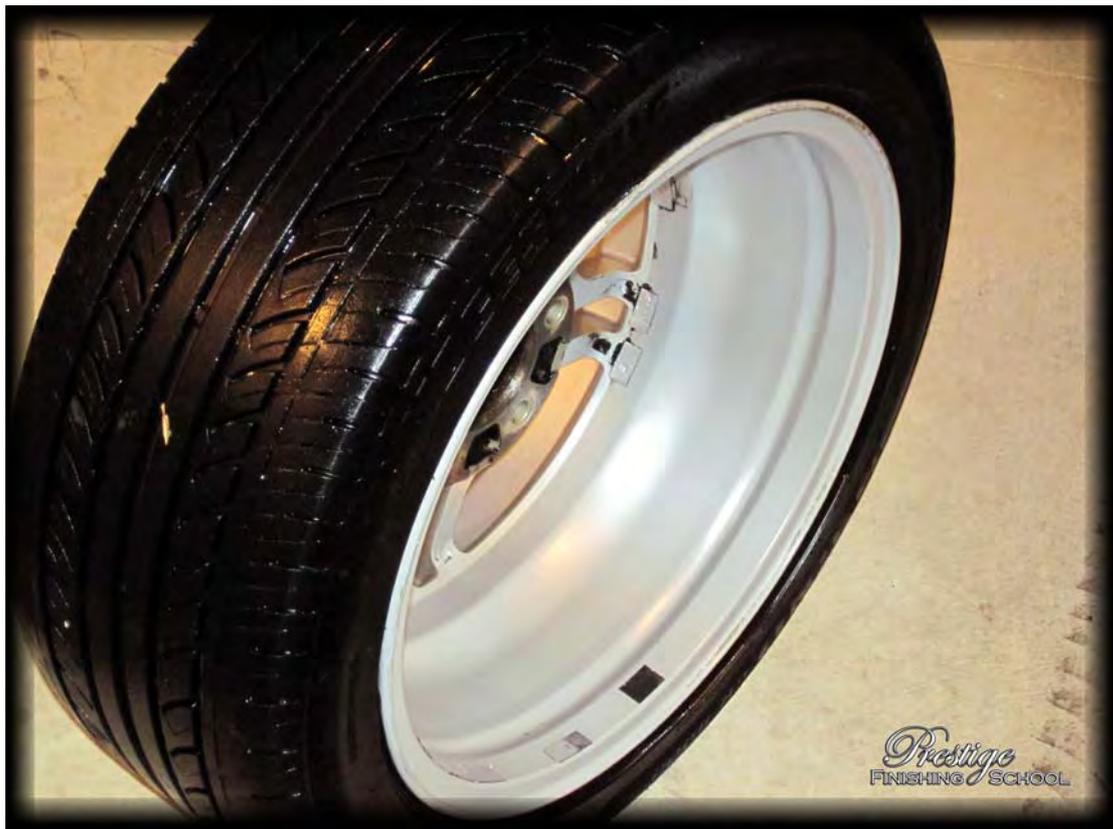
Stepping up the 'aggressiveness' of the cleaning process, we turned to "Meguiar's Wheel Brightener", with the following results.

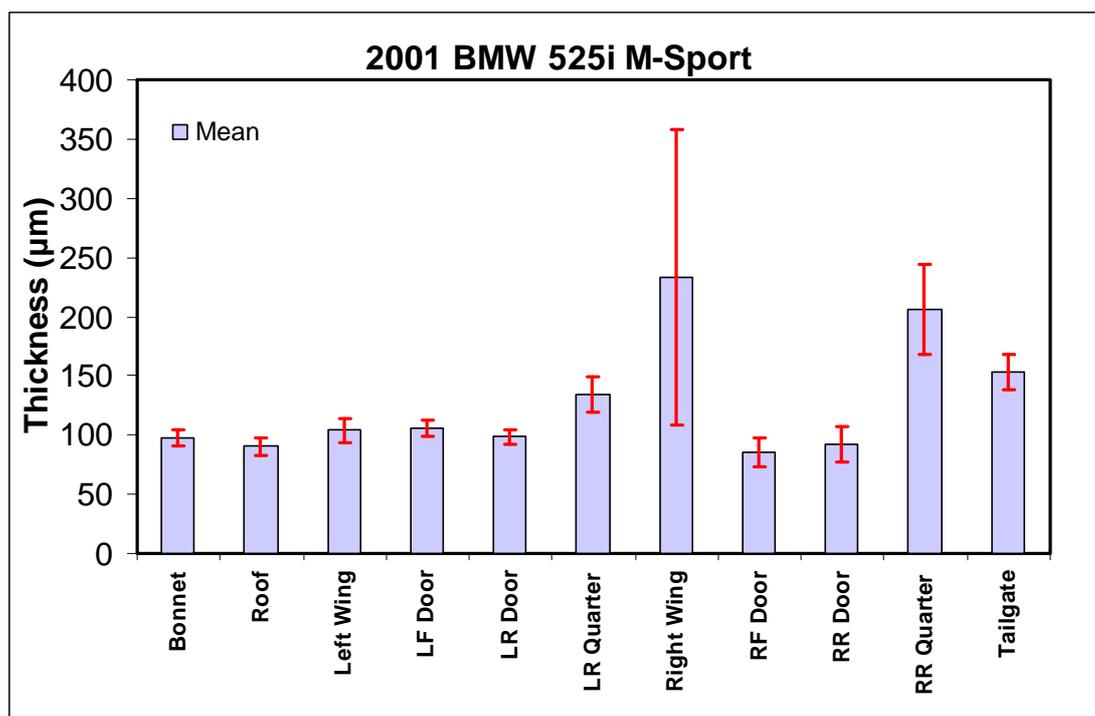
Each panel was carefully assessed to highlight any localised ‘thick’ or ‘thin’ areas that might represent previous touch-up work, or aggressive cutting in a localised area.

This vehicle had healthy paint readings across the board – with evidence of touch-up work having performed on the right front & right rear corners.

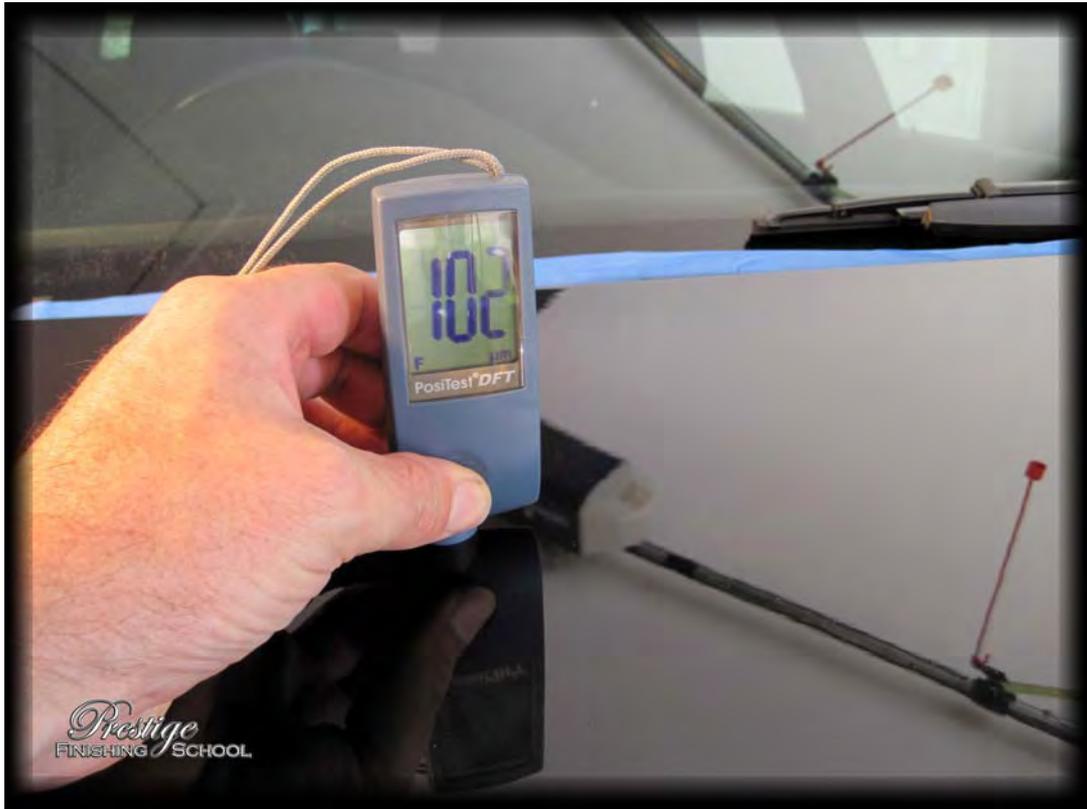
When employing aggressive polishing compounds, it is vitally important to keep a close eye on the amount of paint being removed. Amazingly, this combination was only just starting to touch the paint!

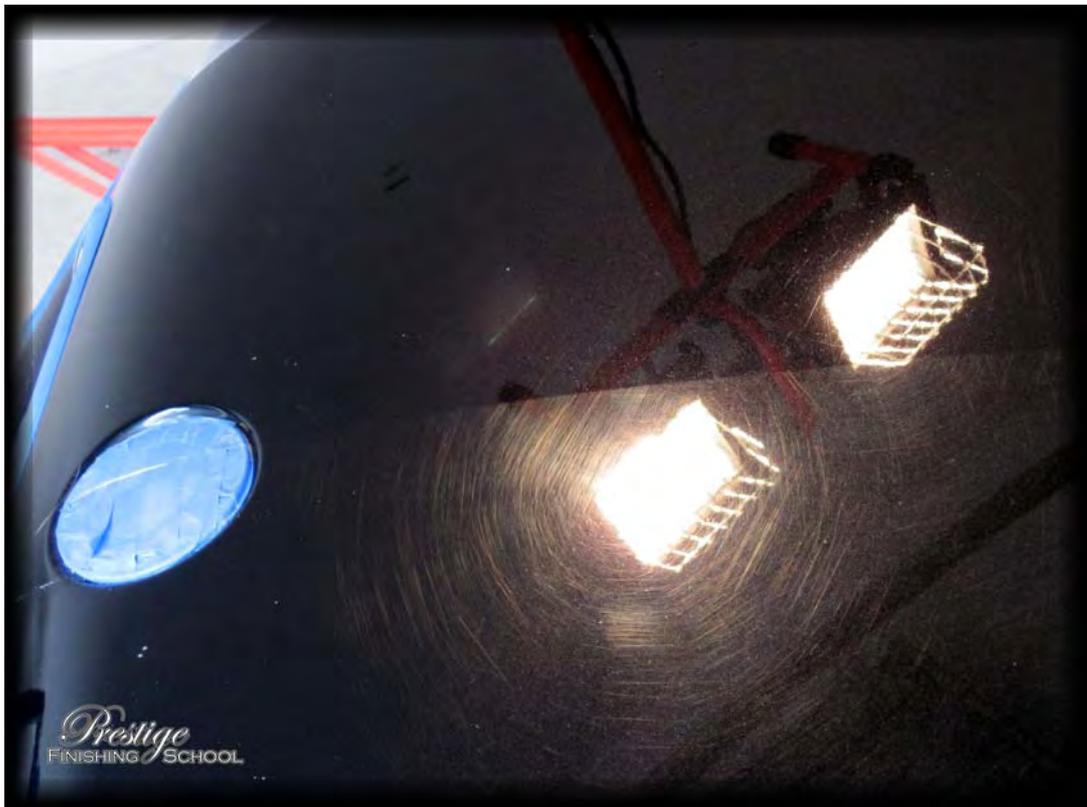
Reassured, we settled on a course of two 'hits' of the compound, followed by a refining stage with Menzerna 85RD which gives a difference that looks like this:

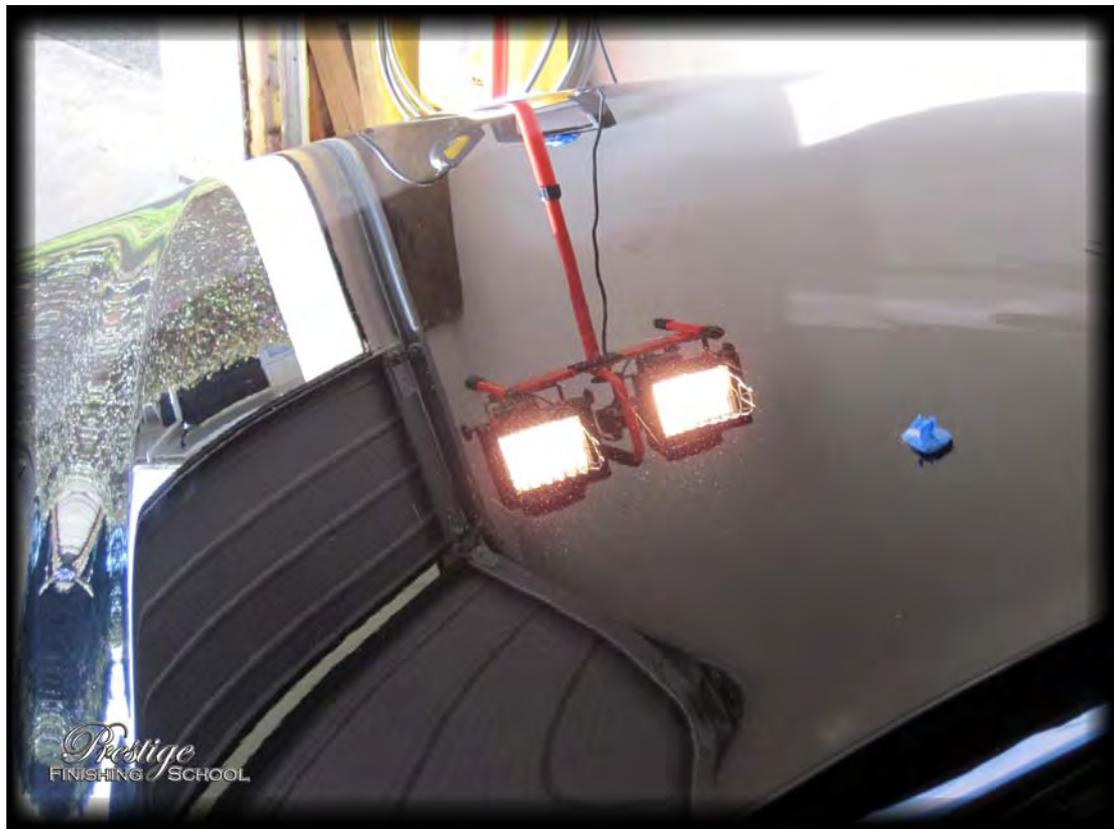
The process is then repeated in sections across the entire panel with the end result showing an enormous improvement in gloss, clarity and reflectivity.

(Please excuse the light smattering of polishing dust in this photo)

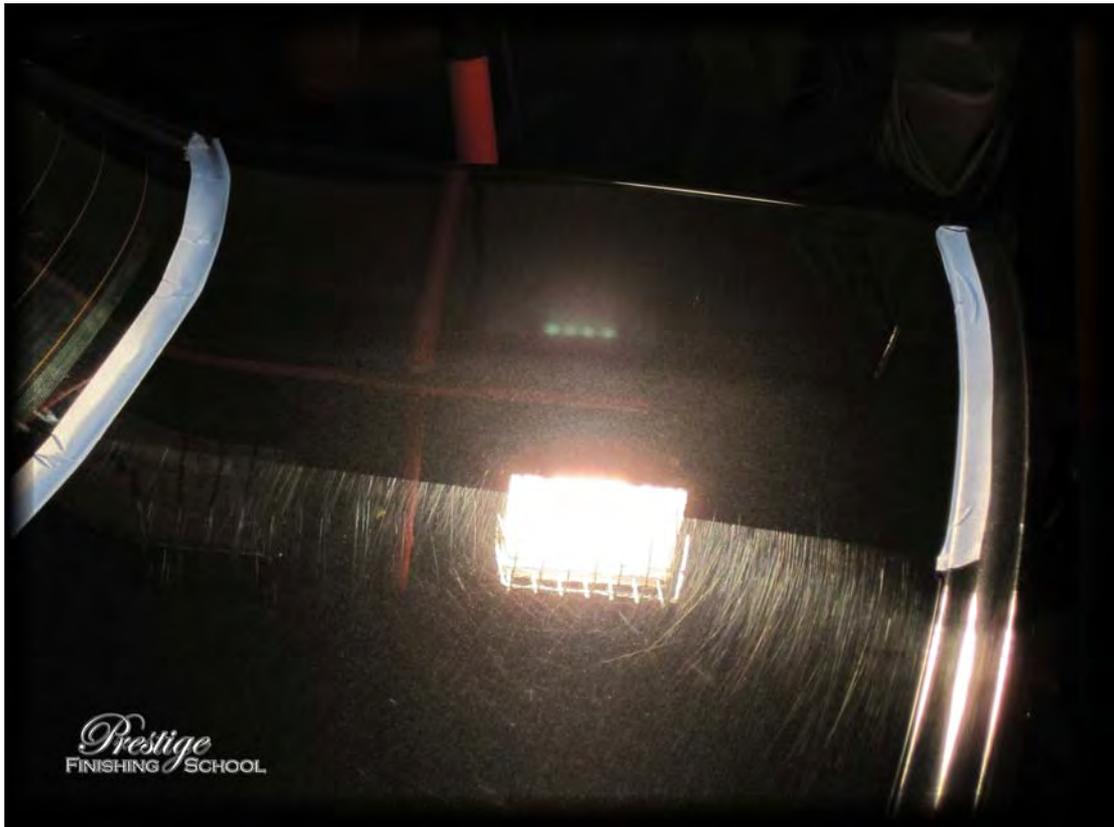
The above is another dramatic illustration of just how badly swirl marks can affect the overall appearance of a vehicle. (And the magnitude of the correction that can be achieved.)

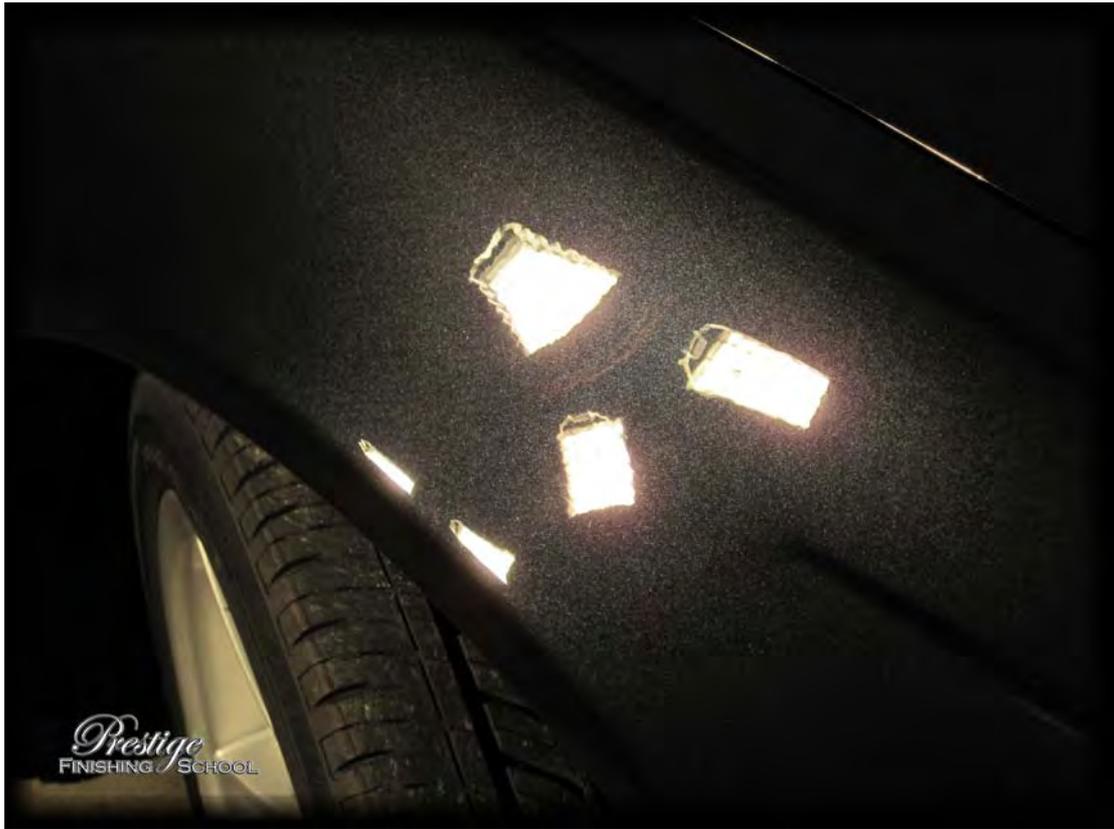
Right Front Wing

This panel had certainly been re-sprayed. Note carefully the 'scale' of the surface measurements in the diagram below and you'll see that it is roughly double that of the other panels so far. Of greater concern is the marked variance in the paint thickness across the panel.

We proceeded with caution... The panel finished perfectly.

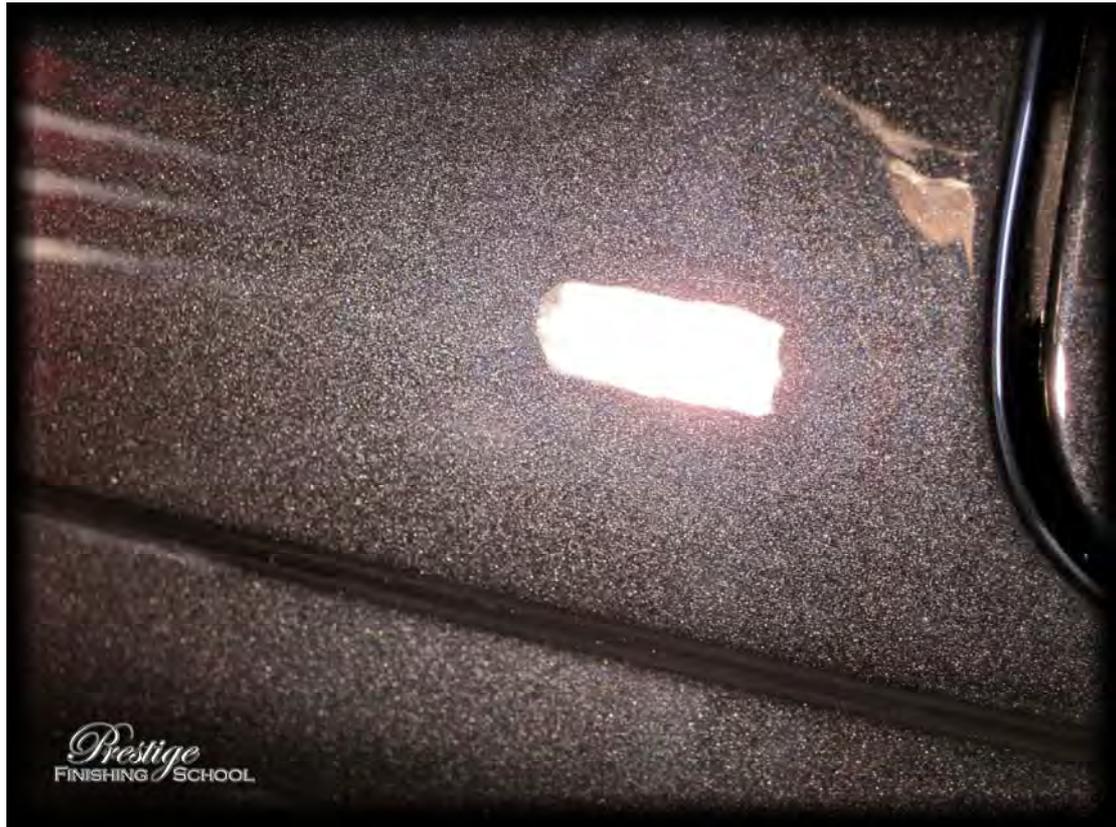
Right Rear Quarter

And a post-correction shot. The metallic flake in the paint really comes alive.

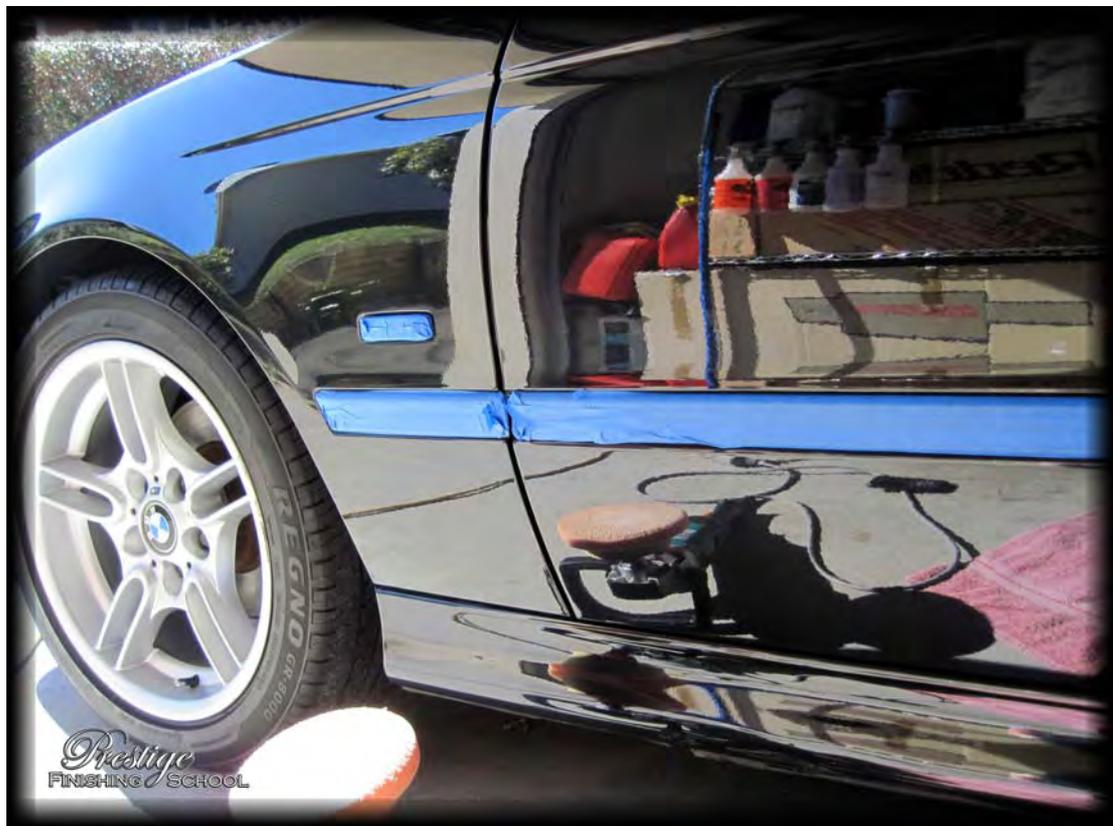
Left Front Door

A few hours on these panels revealed a perfect finish.

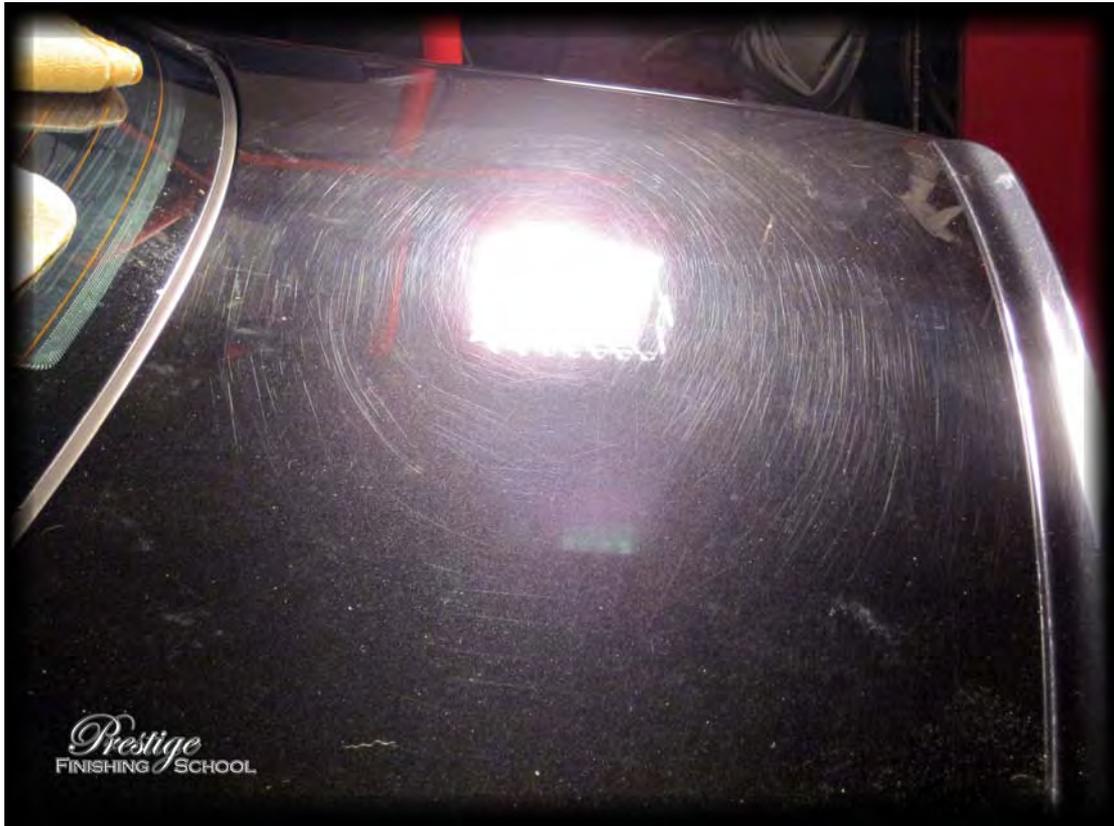
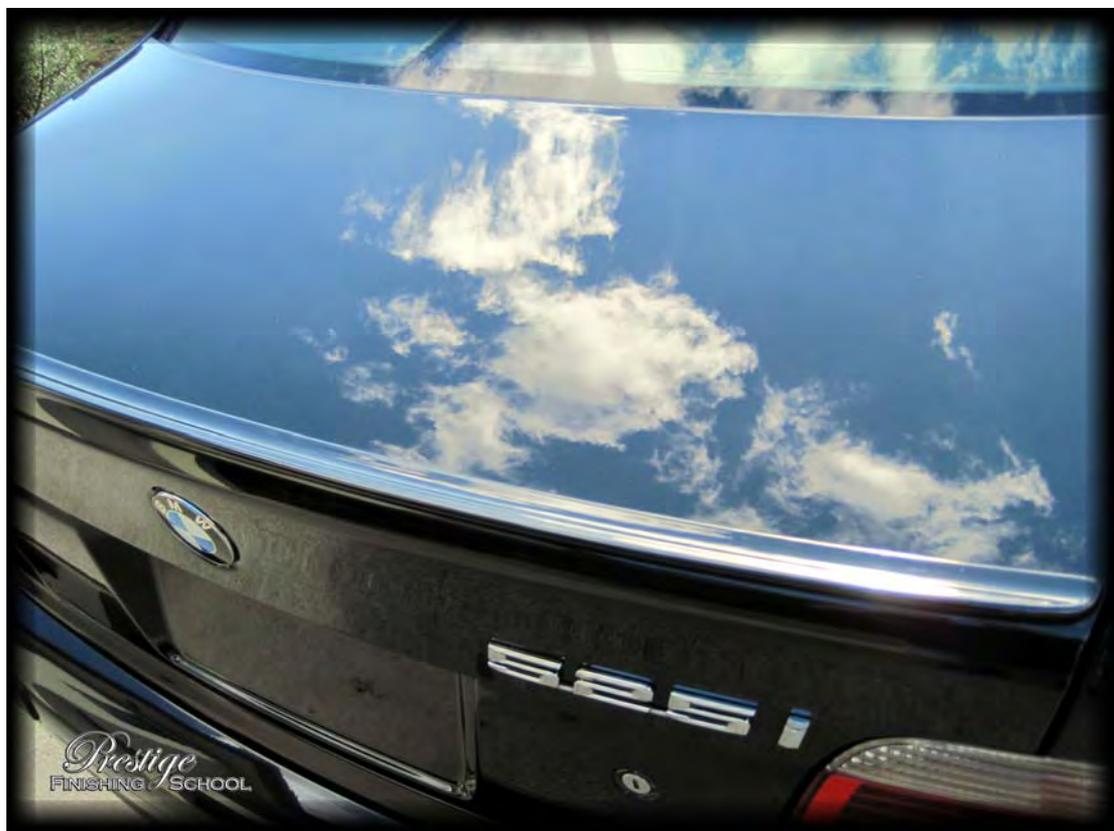
With all the details taken care of, it's time to show off... remember that boot lid?

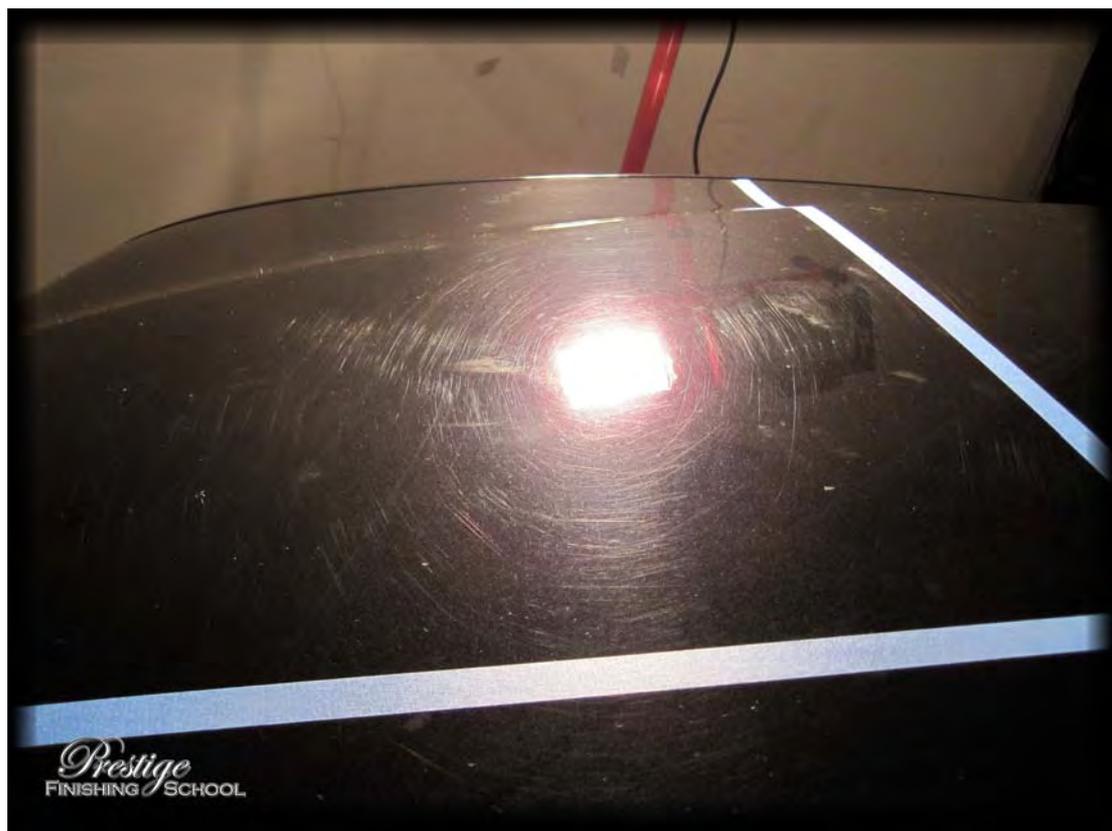
On delivery, the owner's concerns became immediately apparent, with harsh swirl marks clearly ruining the paint's reflectivity and clarity – especially on the bonnet.

...and of course, the bonnet.

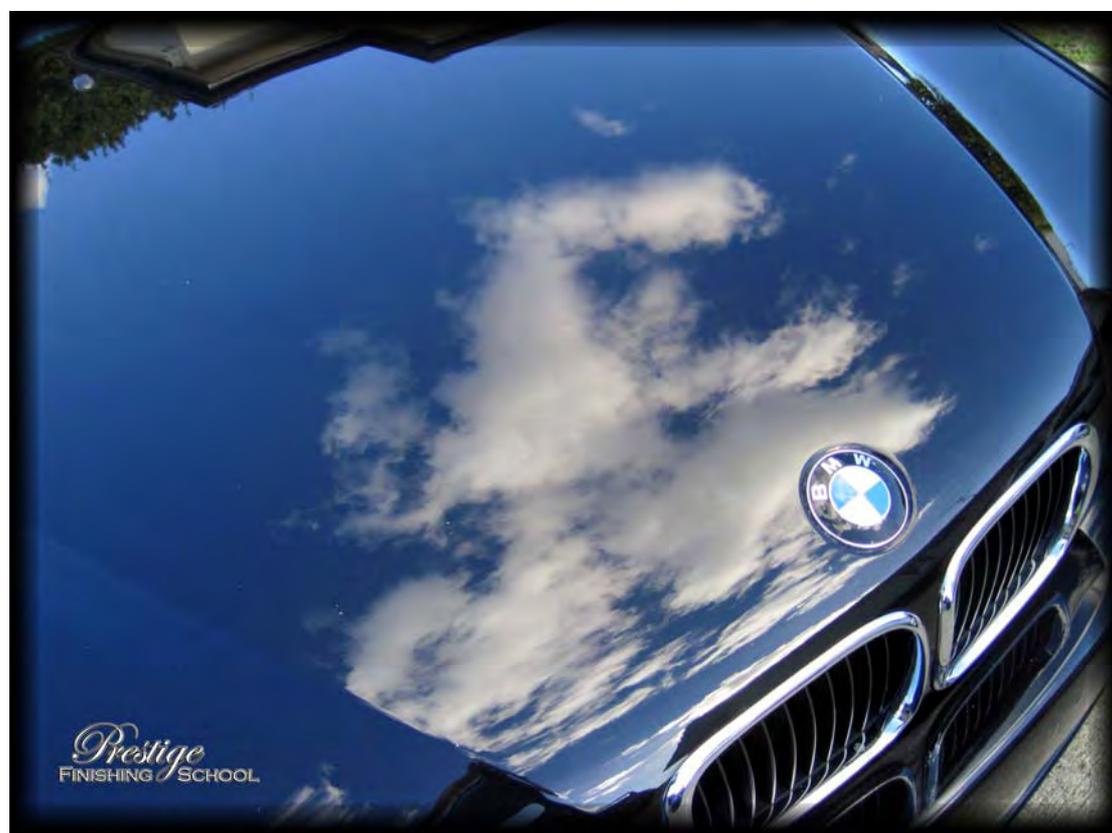
Both panels now absolutely gleaming.
