**Report Card:**

2001 Holden VX Commodore (Red)

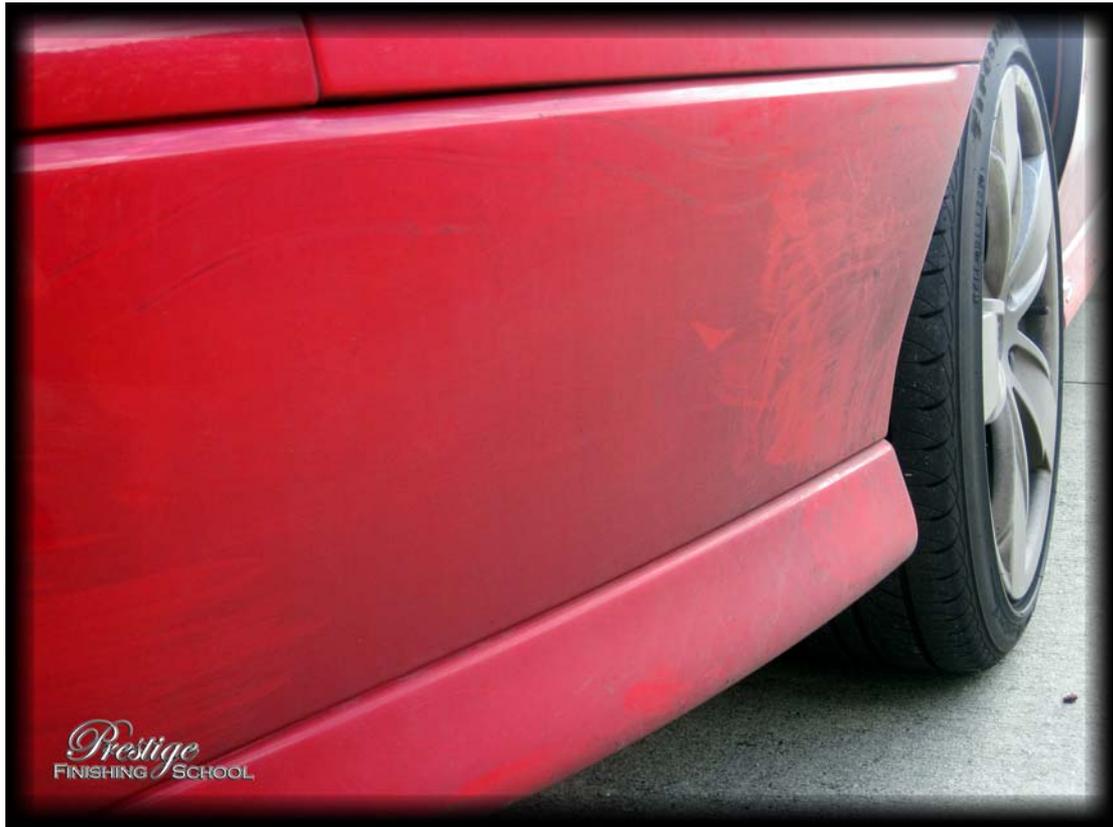
The vehicle was presented with a generous coating of road grime.

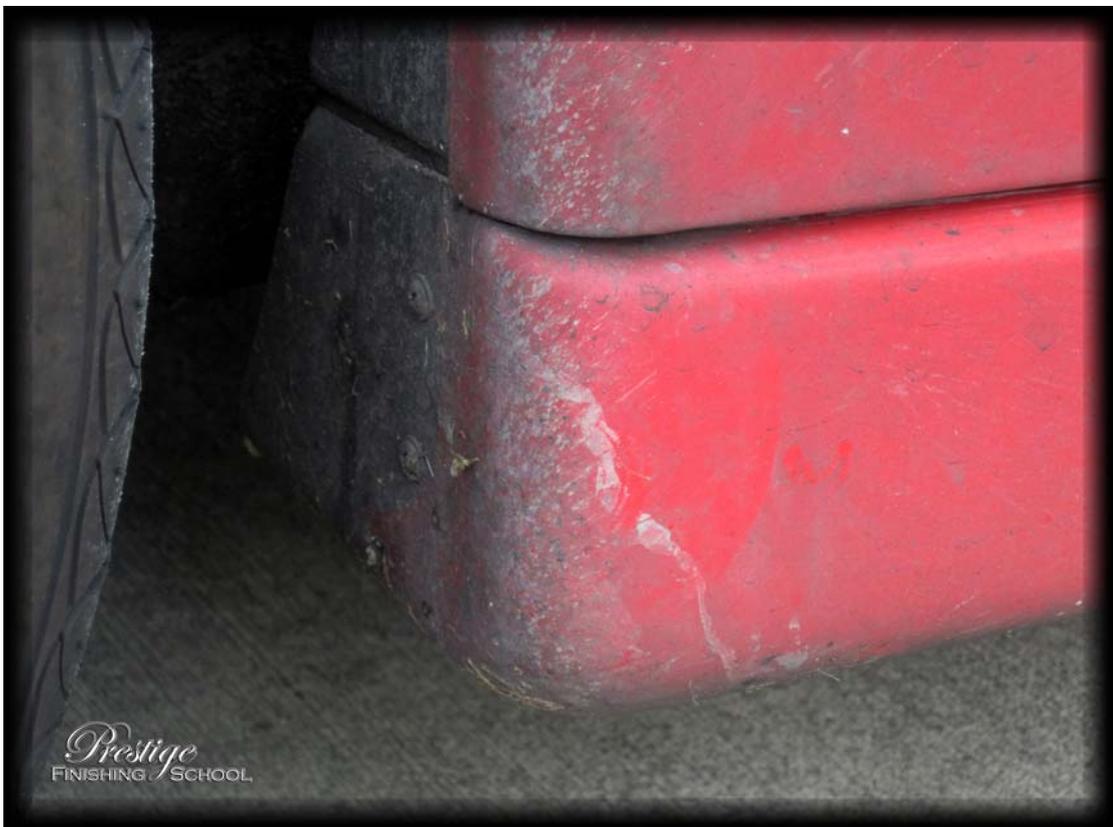
With the usual areas looking particularly grubby.

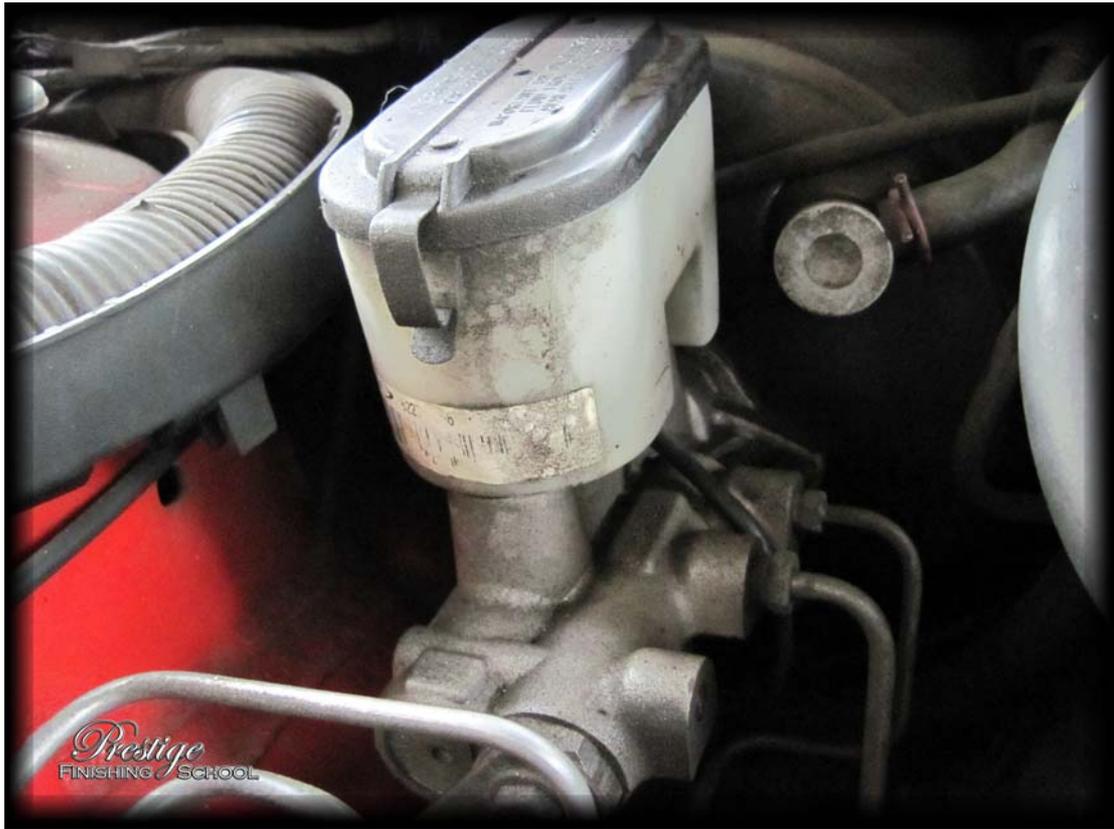
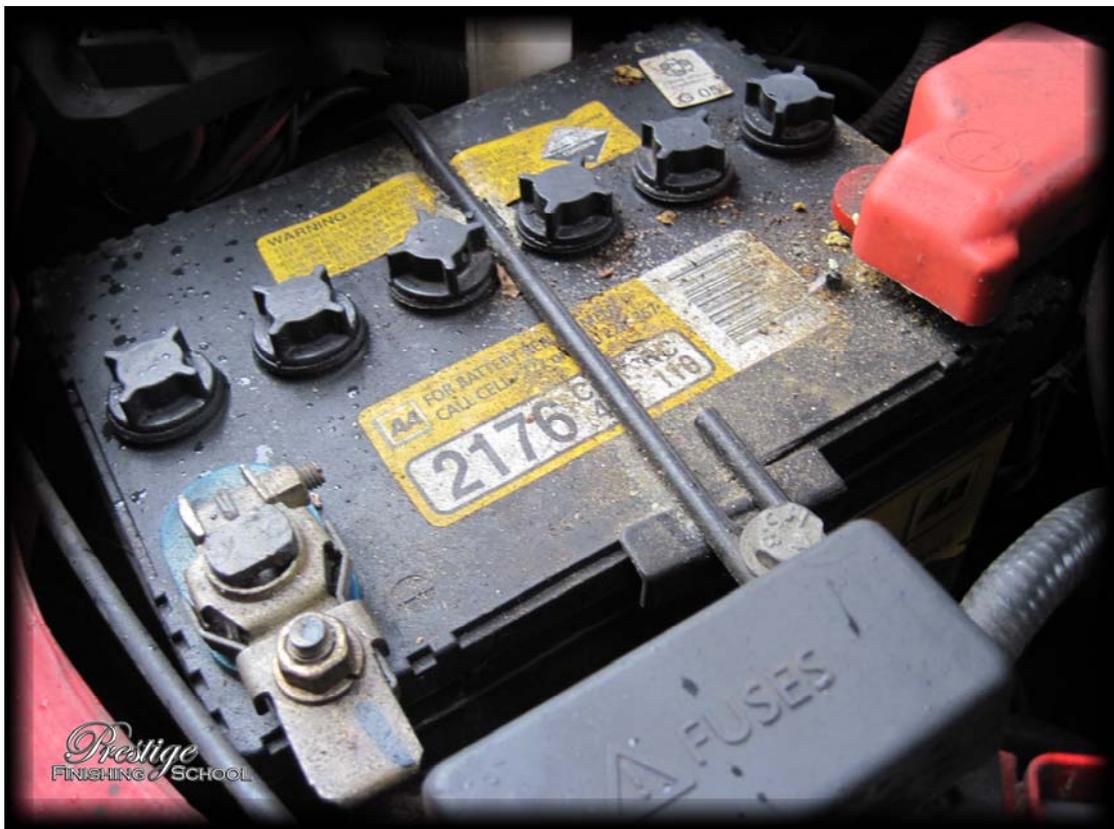
We commence with the Engine Bay. Plenty of grime and dust present, as well as some nasty staining/fading of the plastics.

Getting up close gives an indication of the general state of things...

The entire compartment was given a liberal spraying with Meguiars Super DeGreaser (diluted at 4:1 this time for a little extra bite) and agitated with a detailing brush. This was then rinsed off at low pressure, leaving the following results:

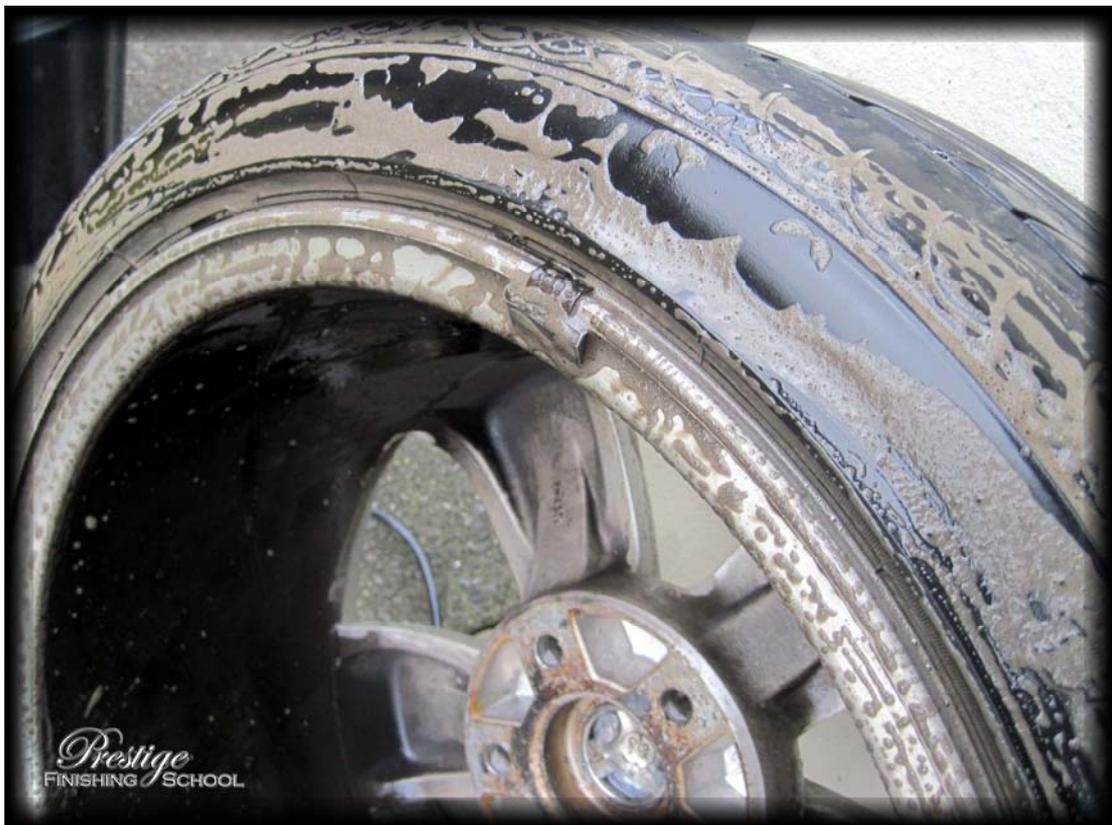
We also scrubbed the tyre walls with “Meguiars Super Degreaser”. Cleaning the tyres is not a common practice, however this picture gives a good illustration of why ‘tyre black’ products can turn brown very quickly if applied to a dirty rubber surface...

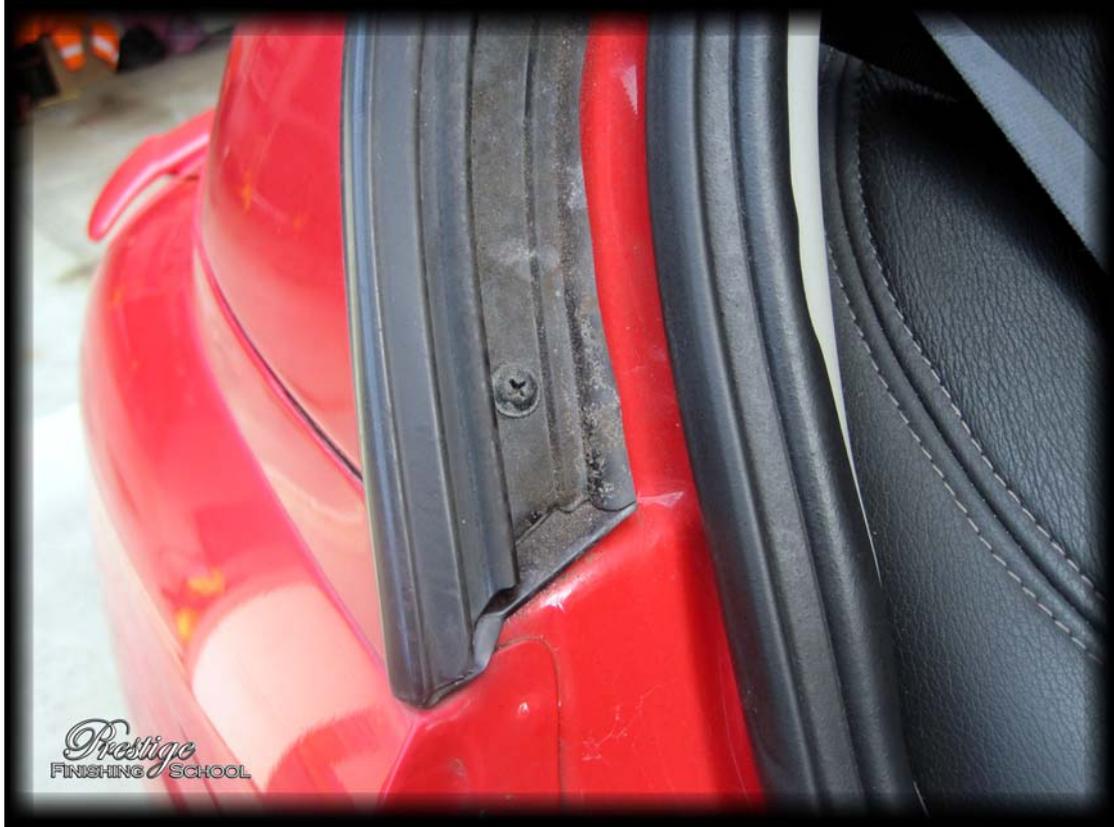
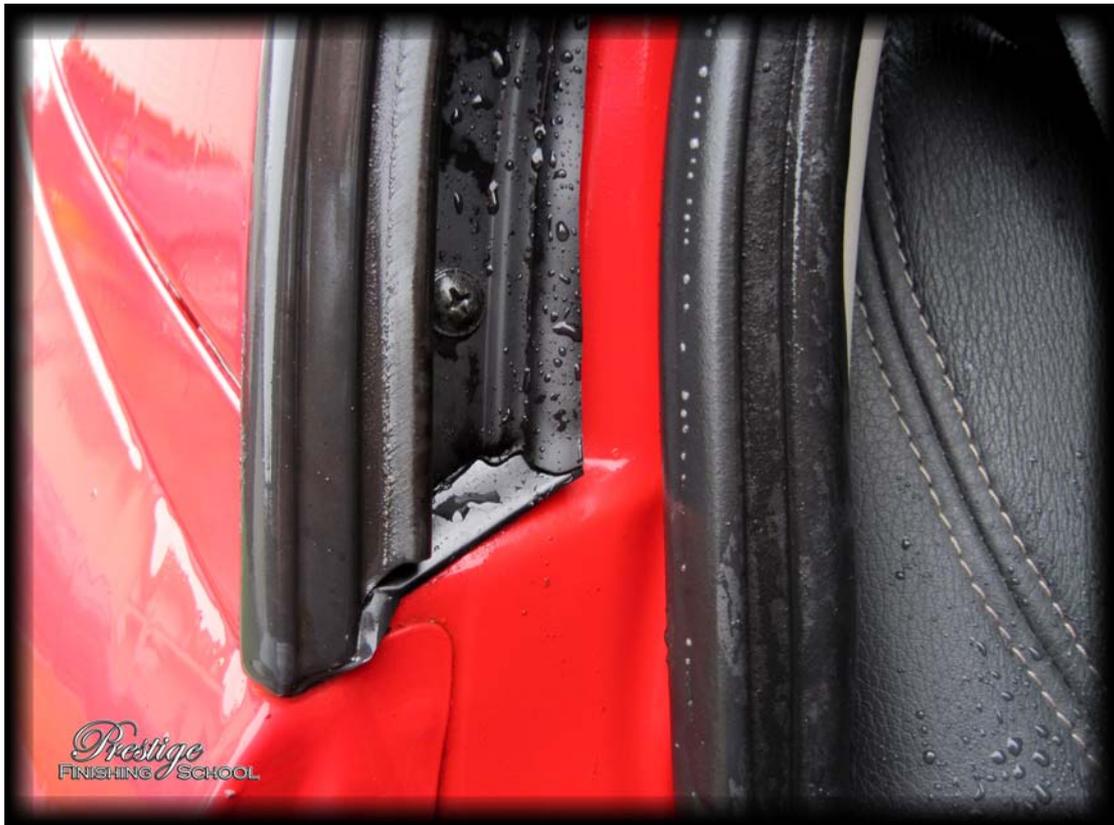
As previously mentioned, this vehicle had spent a long amount of time parked under overhanging foliage. Plenty of dirt had been deposited on the car, and worked its way into various crevices where 'regular' washing won't remove it. Door jambs...

In each case, Meguiars All Purpose Cleaner (4:1) and a detailing brush was employed.

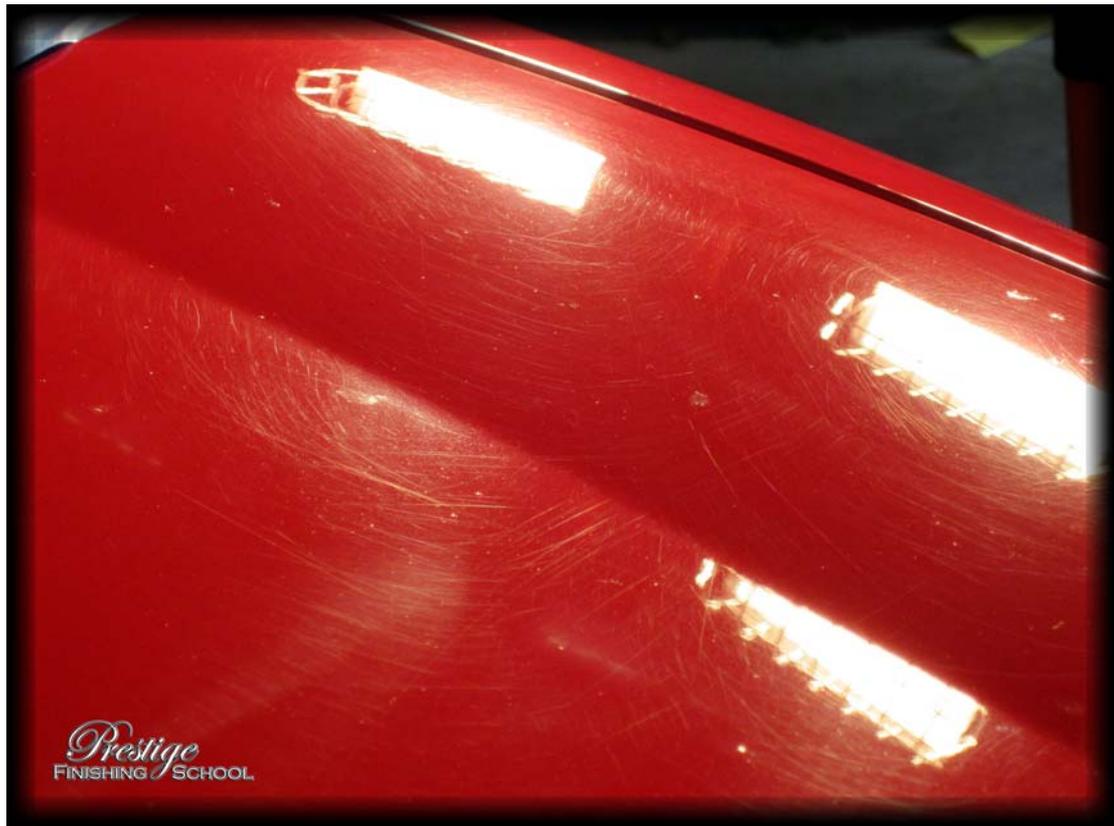
This was the condition of our 'test' area on the bonnet prior to starting.

Mindful of our concern regarding paint levels, we limited ourselves to only very mild polishes and pads, forgoing any cutting or compounding options. The combination that ultimately worked best for this vehicle was Meguiars M80 Speed Glaze on a Meguiars 6.5" polishing pad.

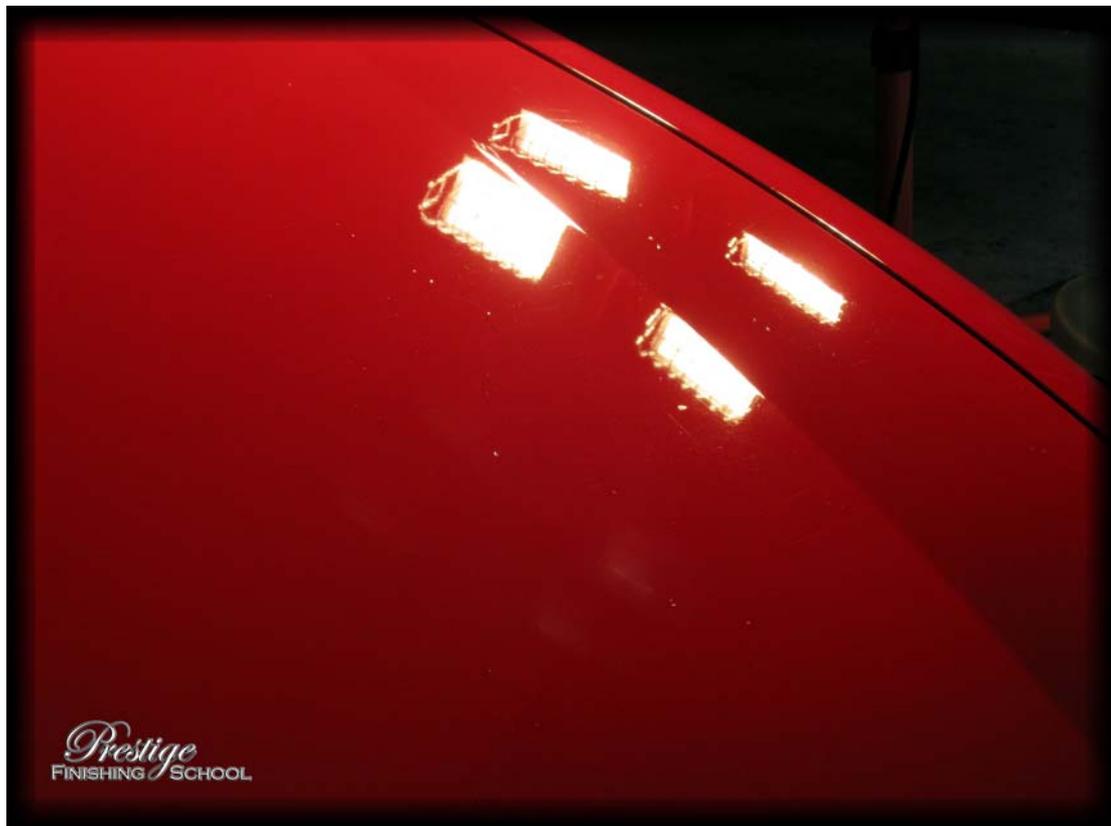
Here the paint has become dangerously thin. (65-70  $\mu\text{m}$ ) Comparative measurements on areas of the vehicle that don't have a clear top coat (Eg. Inside the door shuts) indicated that the combined thickness of primer and colour coats was between 35  $\mu\text{m}$  and 45  $\mu\text{m}$  meaning that as little as 20  $\mu\text{m}$  of clear remained!

By using a Glaze rather than anything more aggressive, and limiting the machining to a maximum of 1200rpm we were able to achieve the following result with only a single micron removed from the top coat.

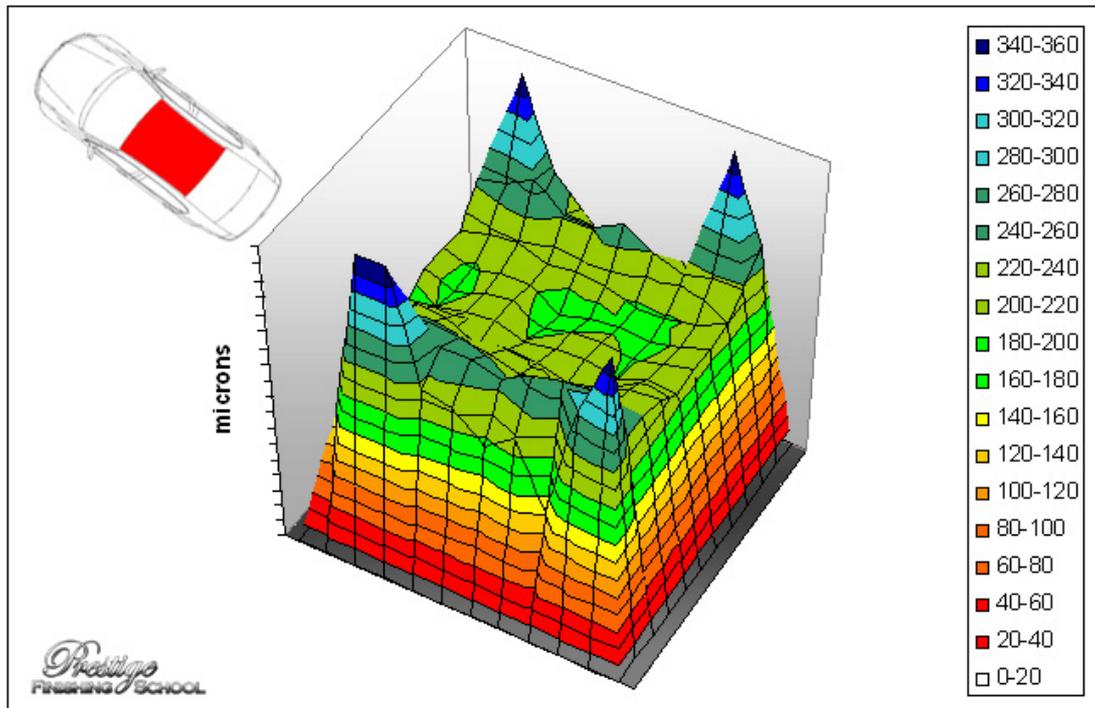
The roof had almost the opposite problem. It had obviously been resprayed (the scale in the diagram below is double the norm) but there is evidence of the newly applied paint 'running' off the top of the roof and pooling in the lower edges.

With a resprayed panel, the total thickness is less meaningful and it becomes difficult to establish how much clear coat remains on top of the many, varied layers of paint on the panel. Again, a cautious approach is called for...

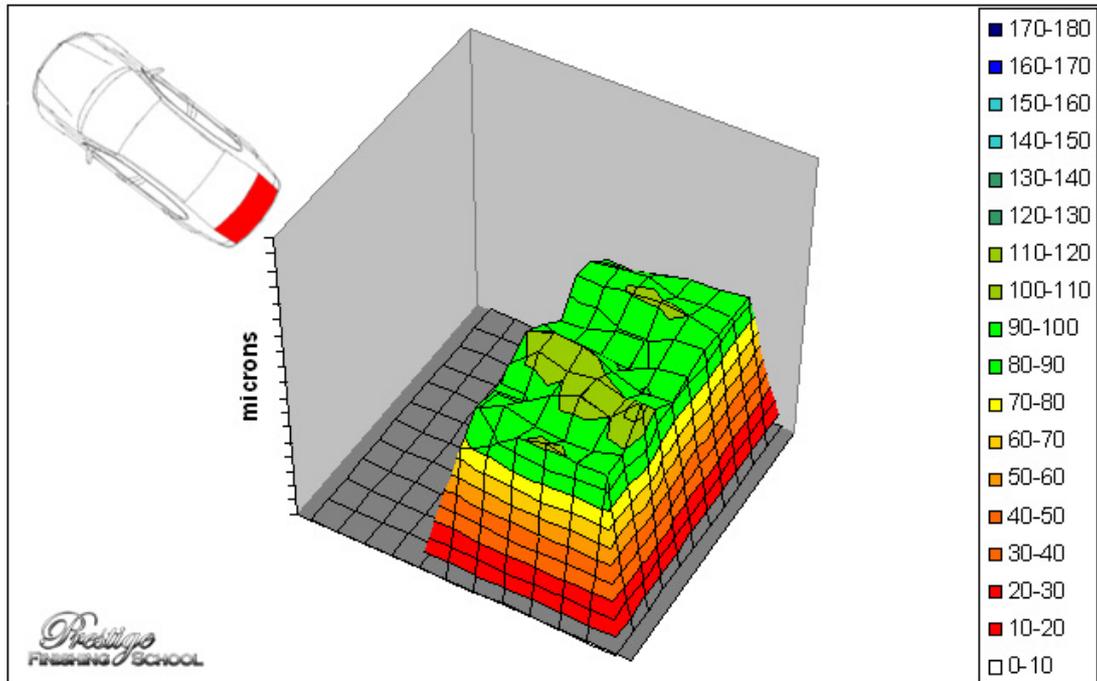
The boot lid showed original, factory paint in reasonably healthy levels. Given that 95-99% correction rates had been achieved with our 'gentle' approach, we opted to persist with this method across the remainder of the vehicle also.

It was, however, looking pretty dire...

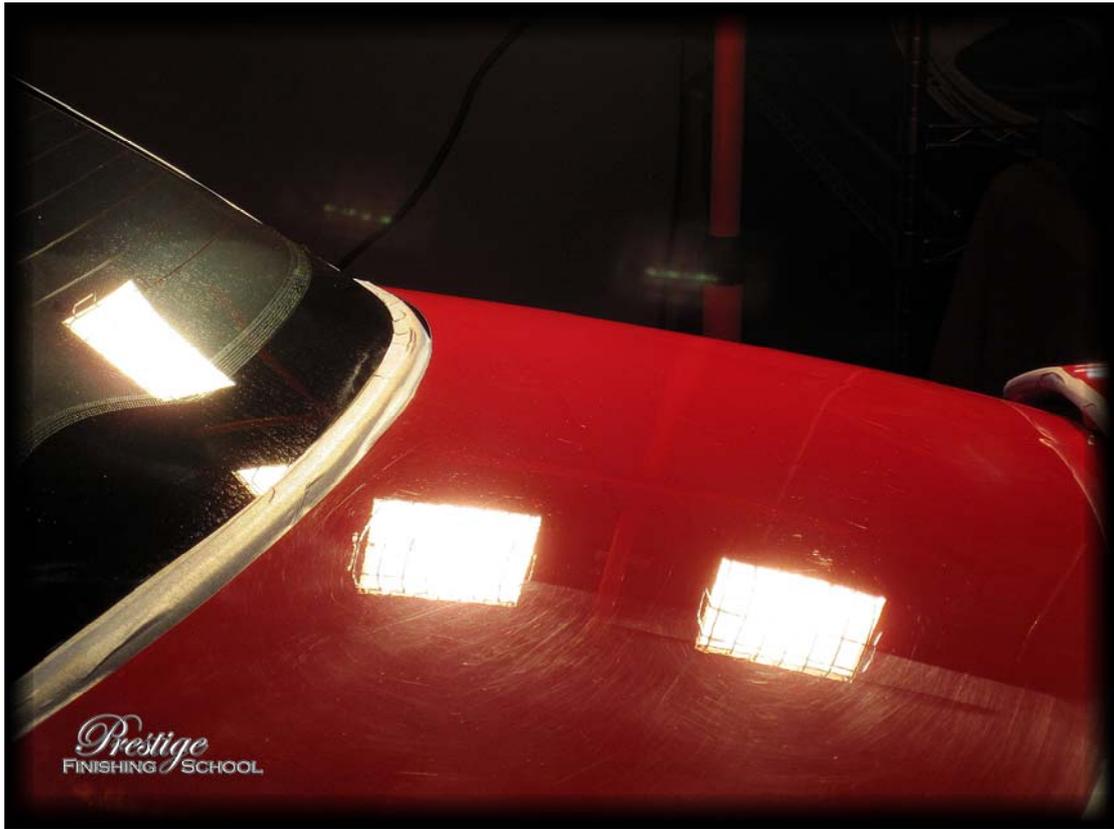
With half the panel corrected, you can really see the difference in the panel's finish.

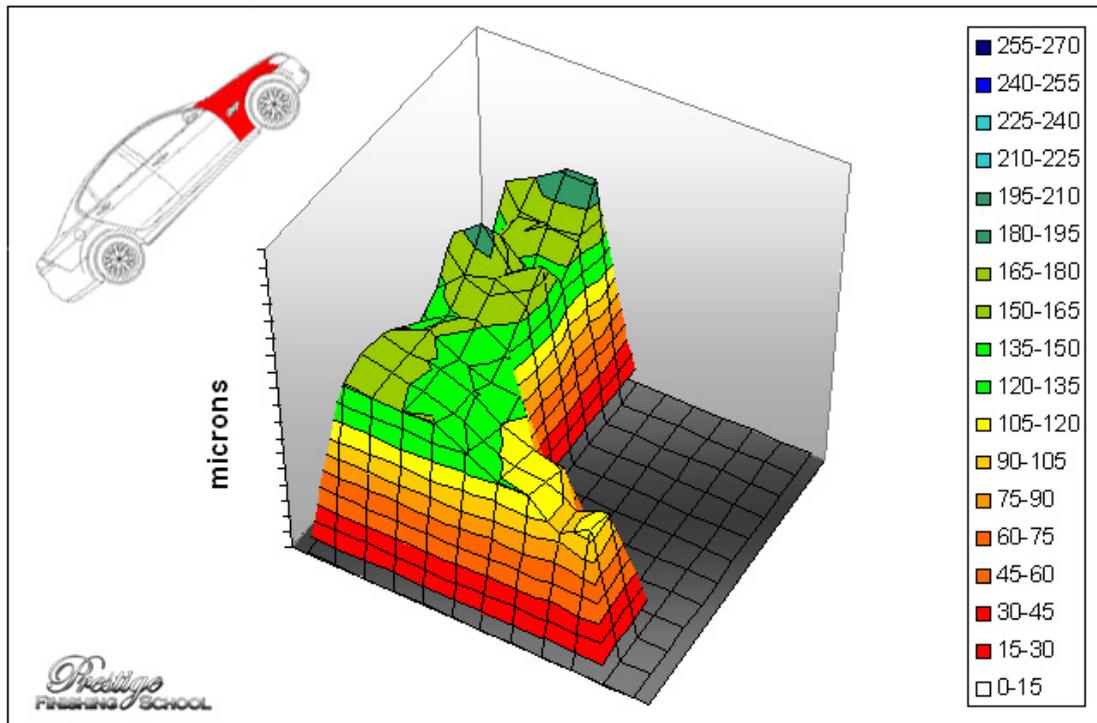
## Right Front Wing

Another re-sprayed panel. (And again, the scale has been increased by 50% below)

The usual assortment of swirl marks and fine scratches can be seen around the light sources.

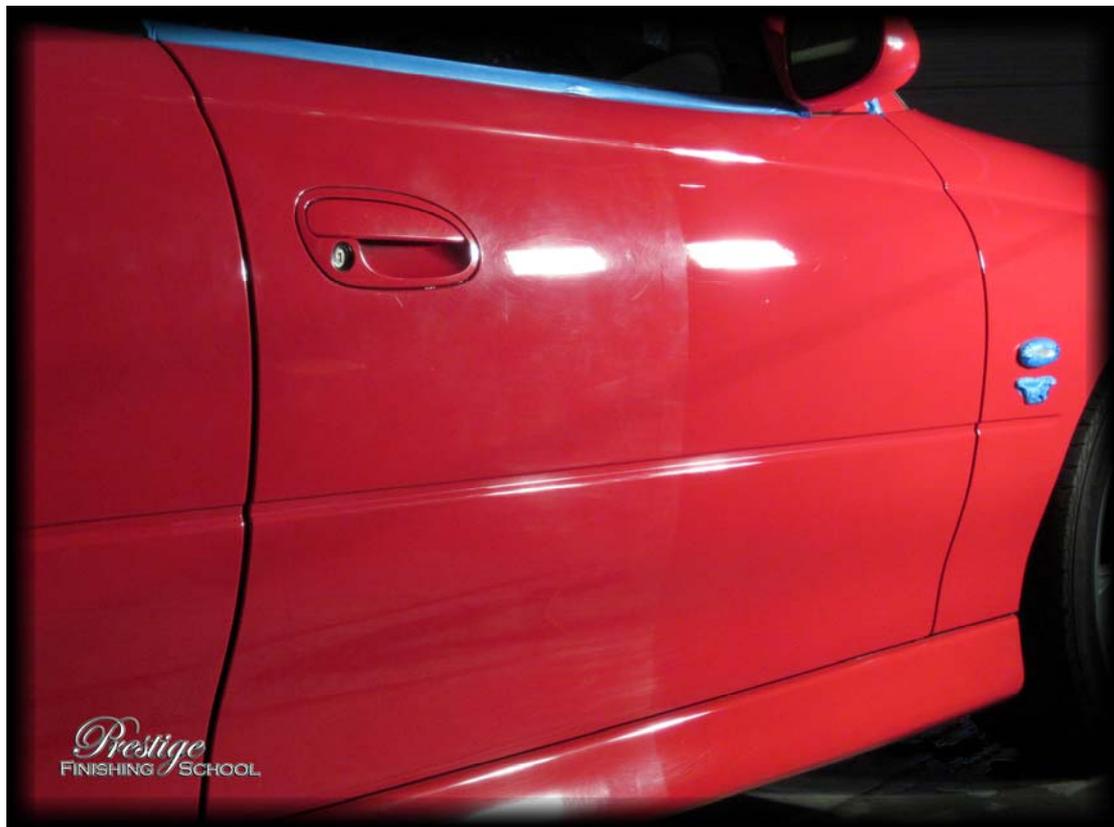
A 50:50 shot of the door during correction. Pink vs. Red!

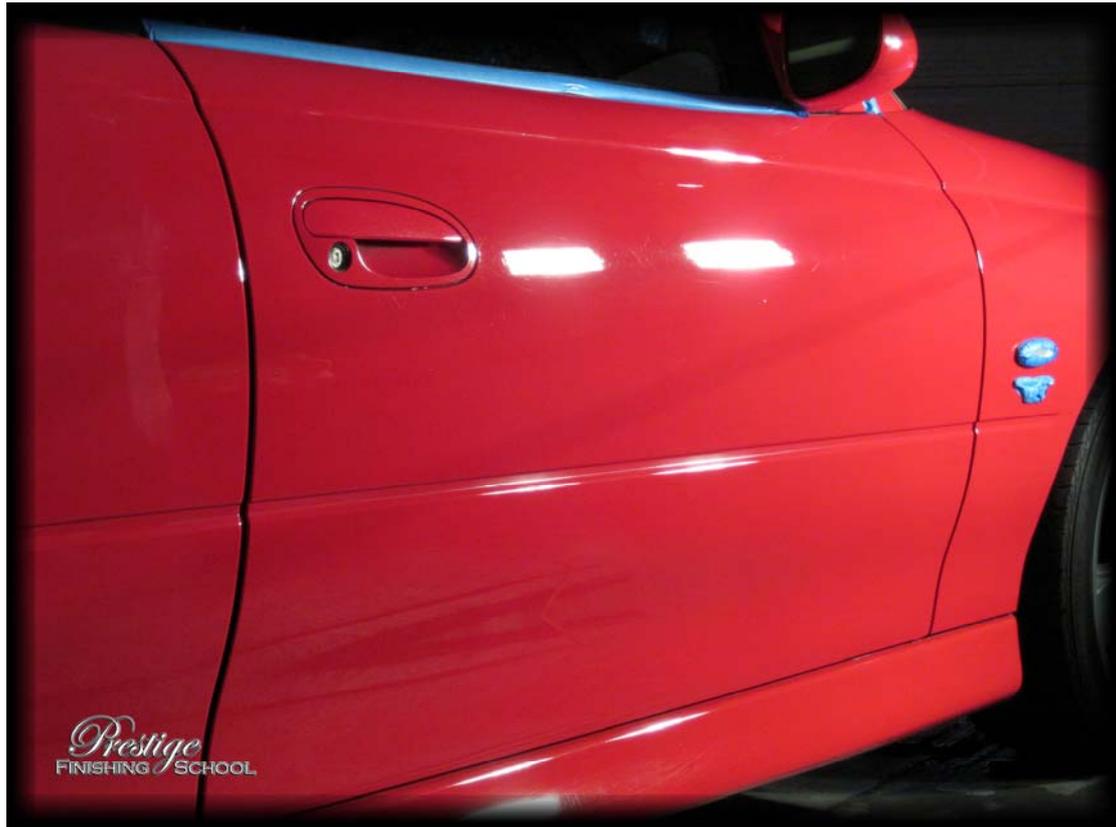
The finished panel.

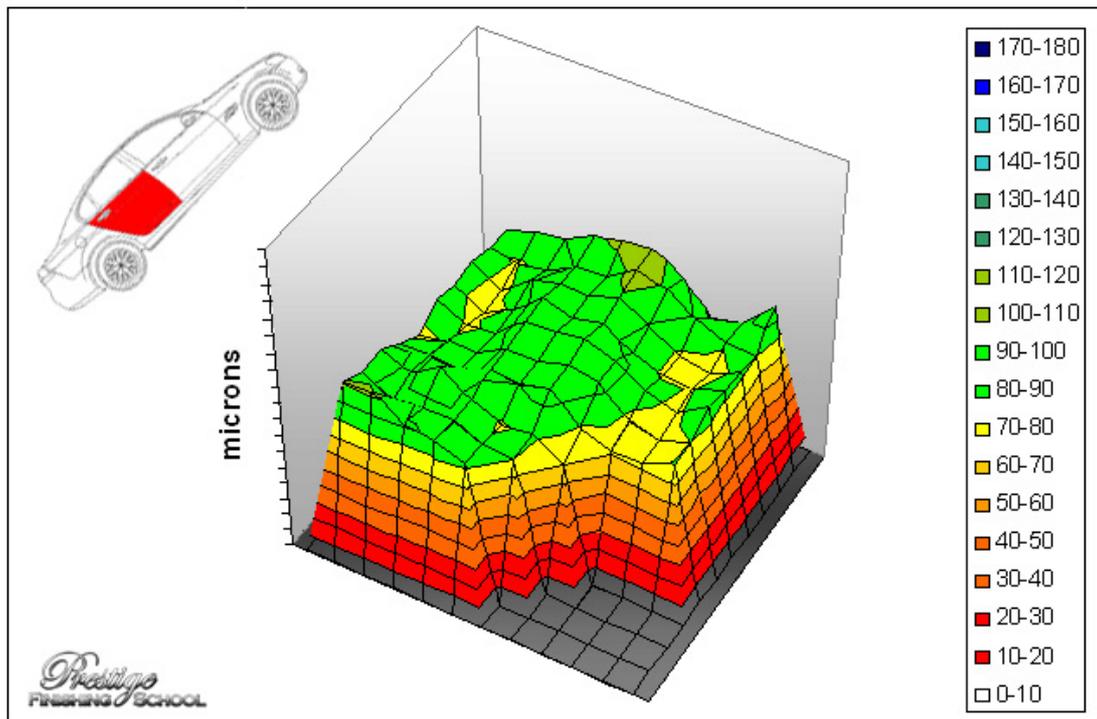
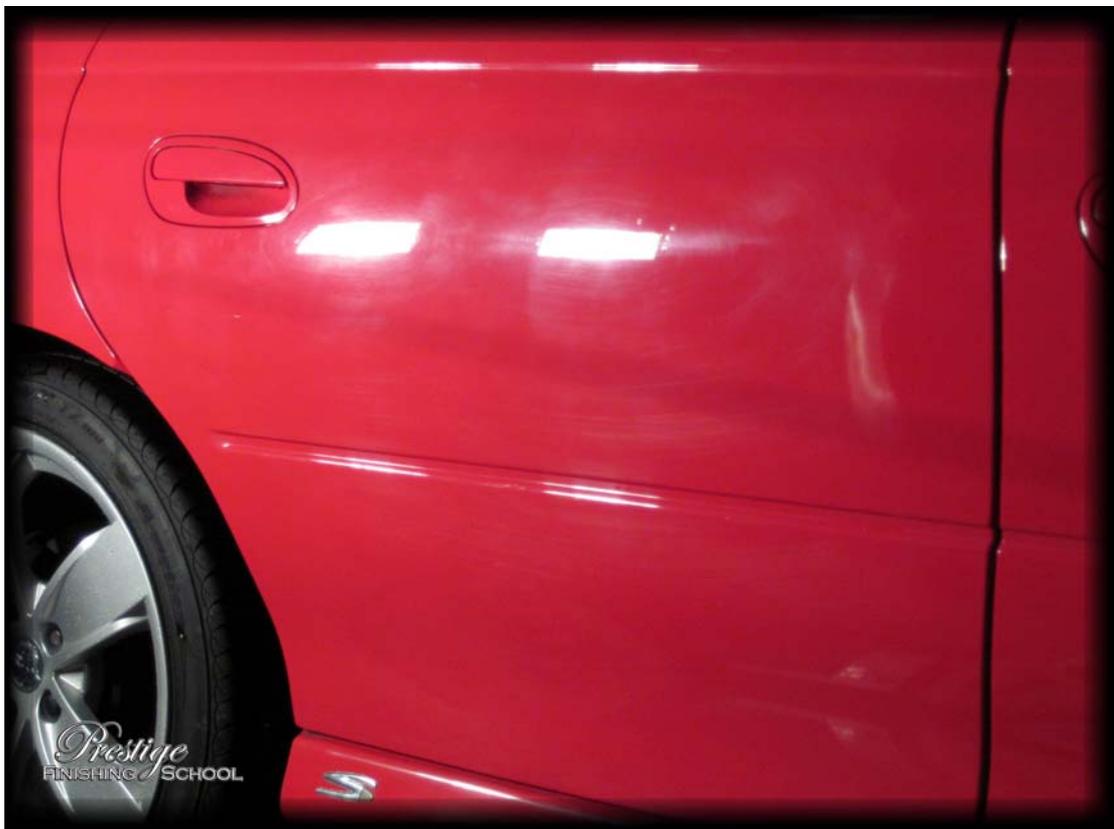
## Right Rear Door

A very similar situation on the rear door.

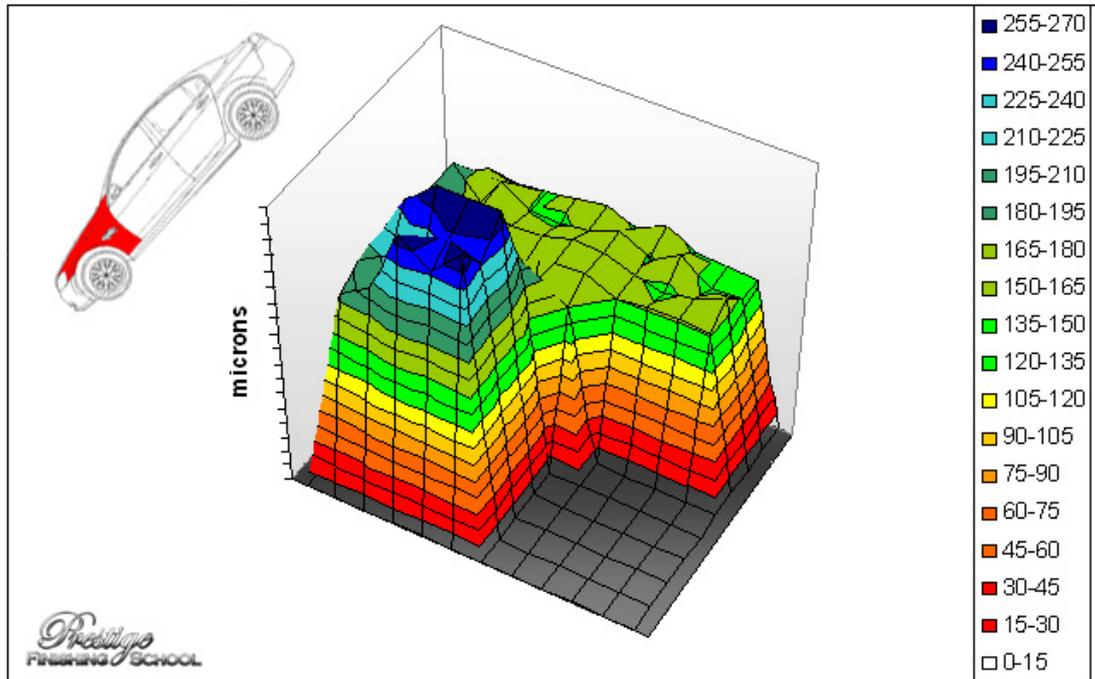
## Left Front Wing

One interesting piece of information that the owner passed on was that after one visit to the paint shop, a panelbeater remarked that he had spent nearly 5 hours polishing to make the repair look right. Look carefully at the thickness diagram below and see for yourself what this caused. (Where the bonnet would meet the Left Front Wing)

This was the re-sprayed panel that led to the bonnet's paint being dangerously depleted. Again, a 50% increase in scale has been applied in the paint thickness diagram below.

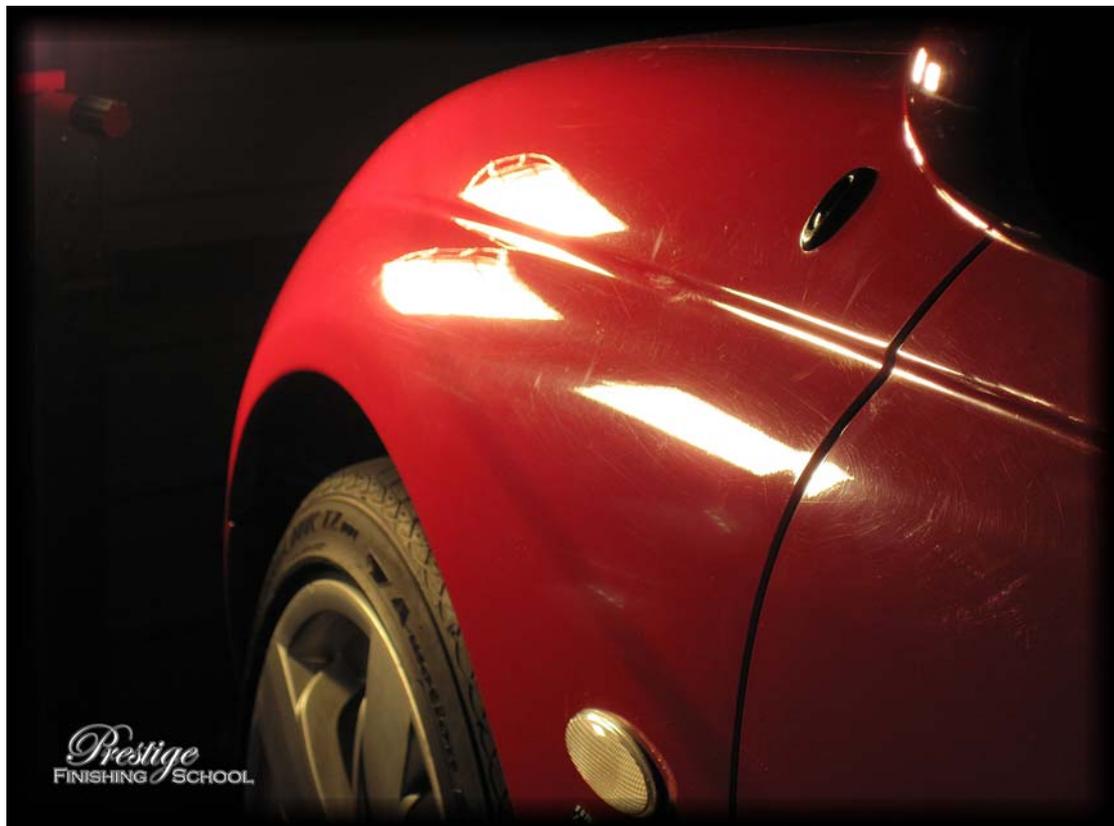
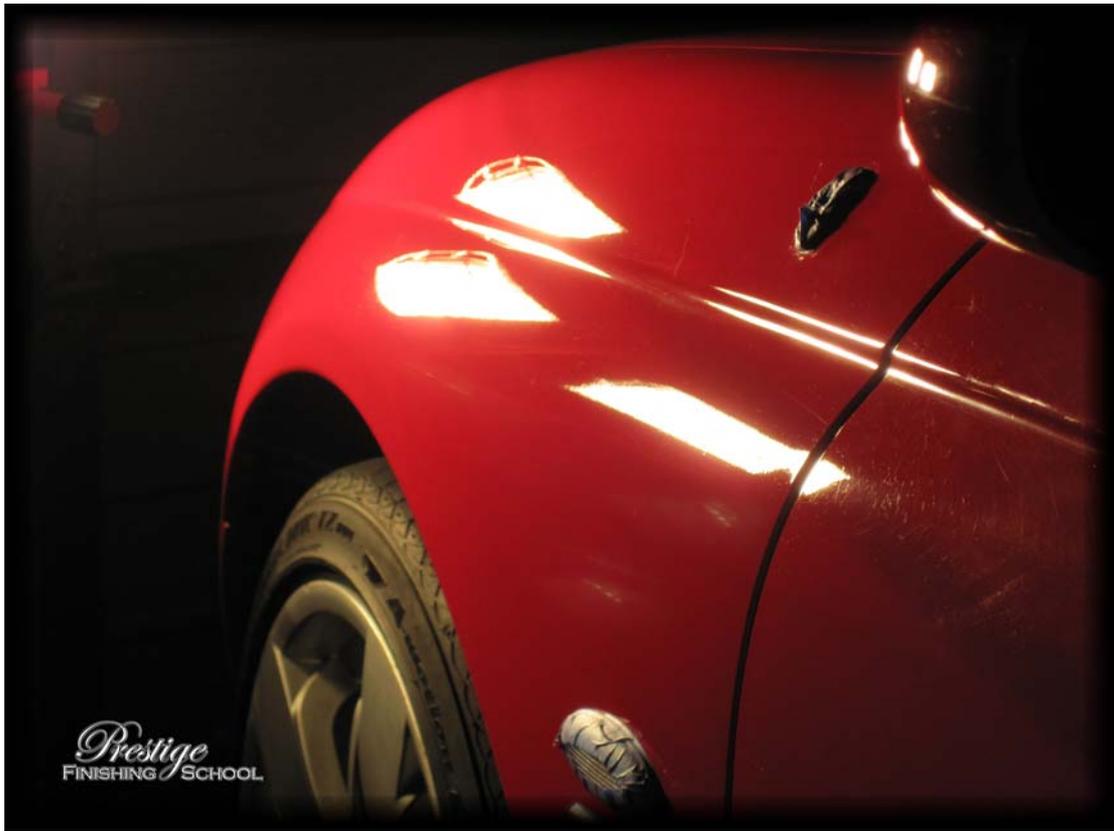
Definitely not the worst looking panel on the vehicle...

...but still markedly improved by the removal of fine scratches. (NB. The edge of the door panel on the right of the photo has not been corrected at this stage.)

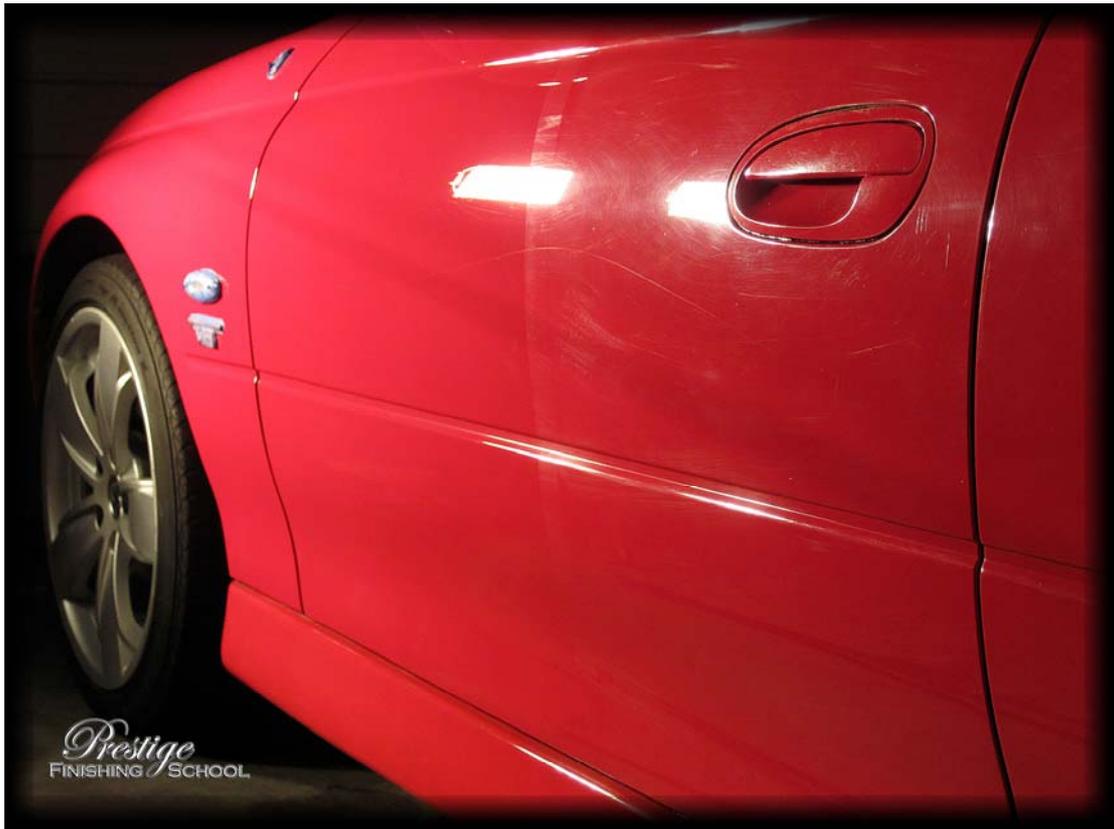
A 50:50 shot demonstrates the level of correction possible without removing a significant amount of paint.

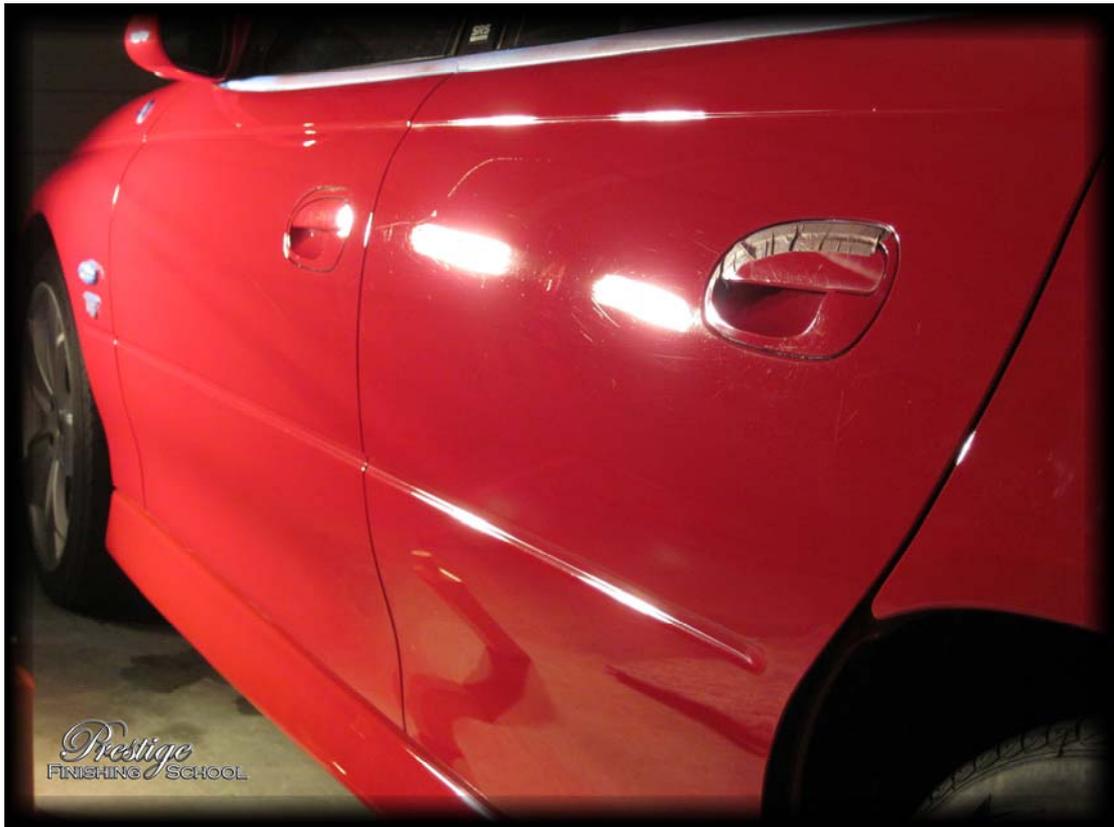
In these situations, it becomes a judgment call on how far to take corrective work before the paint integrity becomes compromised.

Here, a vastly improved panel is the end result, and is achieved without removing large amounts of paint. Removing the last few remaining defects would not be possible without undue risk.

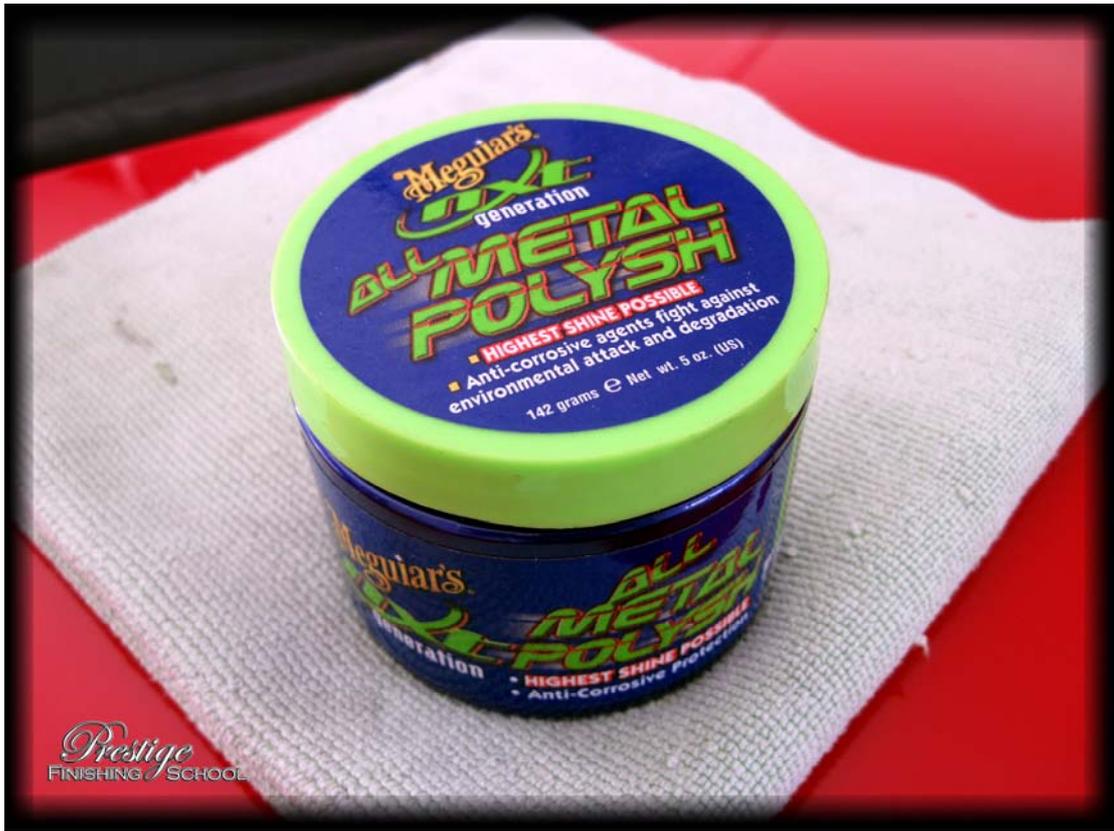
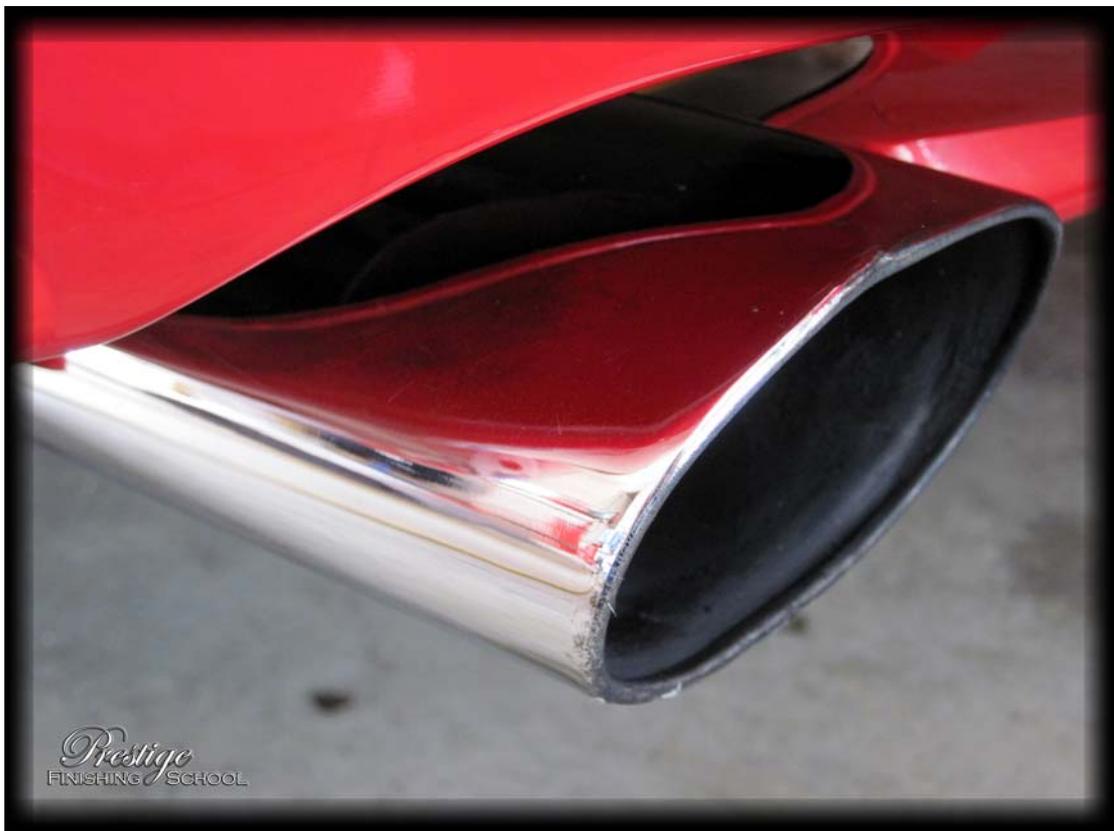
The difference is quite remarkable.

Back to the exhaust – this was cleaned up with the assistance of our “Tar & Glue Remover” and Meguiars NXT “All Metal Polysh”.
